Building Services Condition Report

34 Tarling Road, The Old Barn,
N2 8LG
November 2014

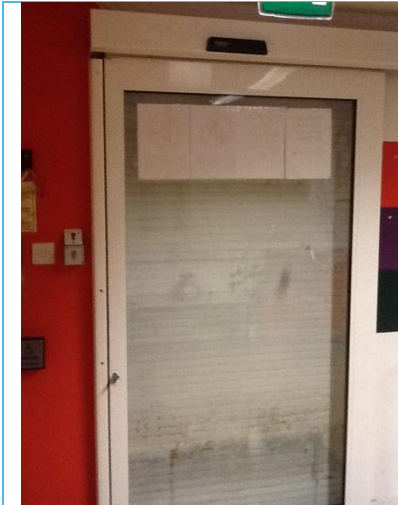
Security Systems	Automatic Doors	Craft Room	Appears in good order, however unable to test at time of survey and no service records available.	None	A	4		001

Img001: Automatic Door

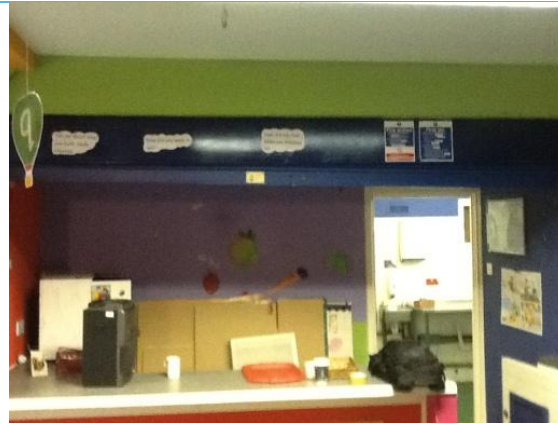
Img002: Automatic Shutter

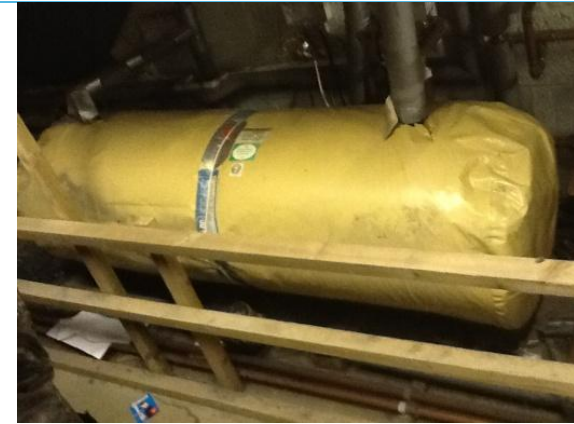
Hot & Cold water	DHWS Heating	1 st Floor Plant Room	Tubular calorifier primarily heated by LTHW but with option for electrical immersion heaters. Immersion heaters appear to have been disconnected. No service or maintenance records for the calorifier.	Due to age and condition his will require replacement.	C	3	£ 22,000.00	003 004

Img003: Calorifier

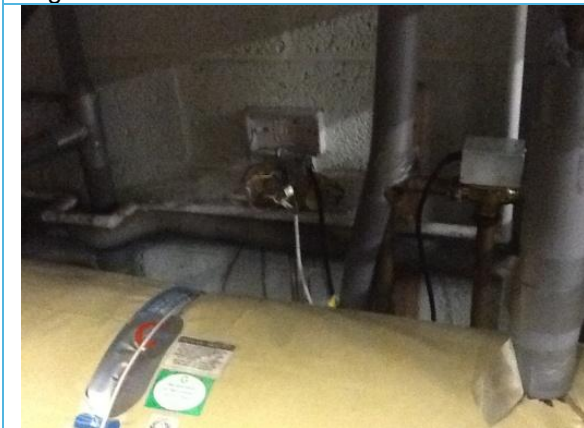
Img004: Disconnected Connections to Calorifier

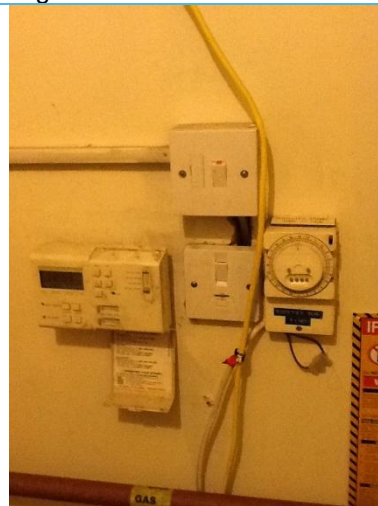
Element	Material	Location	Comments on defect	Remedial work	Condition Rating (A-D)	Priority Rating (1-4)	Cost	Photo
Control Gear	Generally	Ground Floor Plant Room	Controls are tired, offering limited intelligent control	Renew on age and energy saving considerations	B	2	£ 14,000.00	005
Power	Mains Incomer	Ground Floor Plant Room	Mains incomer appears to be rated at 100A, however this could not be confirmed at the time of the survey. Equipment is tired but serviceable. Service sticker indicate system has a current T&I, however this was not available at time of survey.	Renew as part of any refurbishment programme.	B	2	£ 24,000.00	008
Power	Metering	External	Electricity meter is outside the kitchen fire escape. Access to the meters was not possible as access panels are fixed in place presumably due to vandalism in the past.	Remove access panels for proper survey	B	3	£ 190.00	009

Img005: Controls

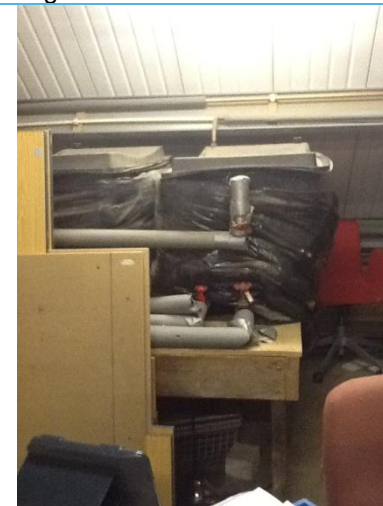
Located within the first floor plant rooms are 2 plastic non-section cold water storage tanks.

These tanks were in service at the time of the survey, however as part of any renovation/redevelopment strong consideration should be made to convert the building to Mains Cold Water to reduce any legionella risk.

Img006: Water Tanks

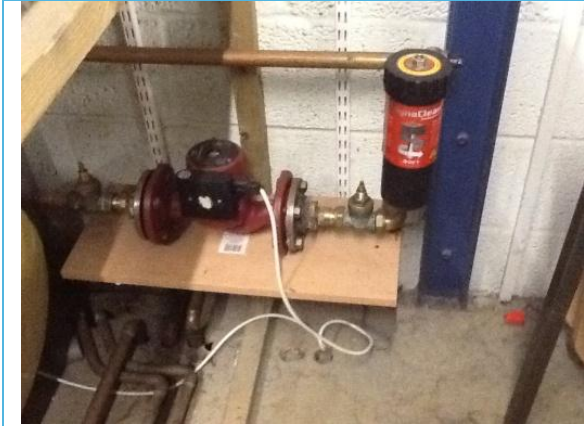
Element	Material	Location	Comments on defect	Remedial work	Condition Rating (A-D)	Priority Rating (1-4)	Cost	Photo
Hot & Cold water	DHWS Circulating Pump	1 st Floor Plant Room	Grundfos Circulating Pump, appears in good condition, however not running at the time of the survey	None	B	3		007
Hot & Cold water	Generally	Throughout	All appeared mechanically sound with only evidence of historic leaking	None	B	4		
Gas distribution	Generally	Ground Floor Plant Room	The main gas meter is located within the ground floor plant room and serves the boilers only via a 28mm copper main. There did not appear to be any other gas appliances within the building	None	A	3		012
Ventilation	Kitchen Extract	Kitchen	A large extract canopy is located in the ground floor kitchen. At the time of the survey there was evidence of periodic filter cleaning and there was no undue noise or vibration when the fan was run	None	A	3		015

Img007: DHWS Circulating Pump

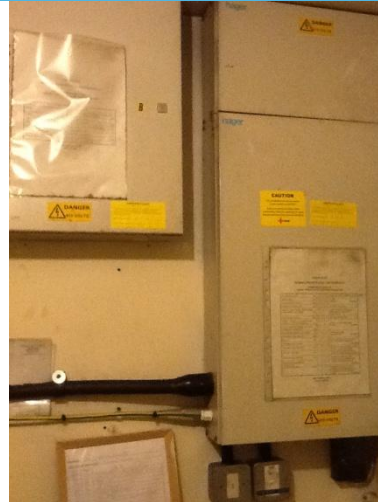
The main incomer is rated at 100A however there was no way to confirm at the time of the survey if this corresponded to the metered supply.

Img008: Incoming Supply

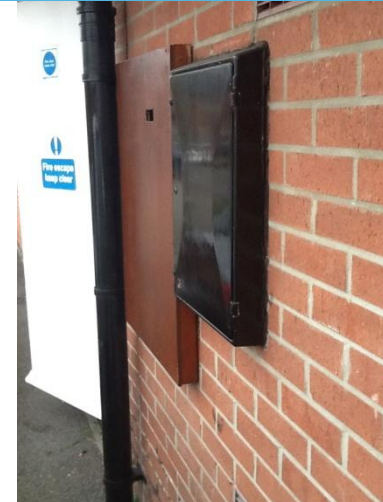
The electricity meter is within an enclosure which is screwed shut and painted over, with only a small window to allow the meter to be read.

Img009: Electrical Metering

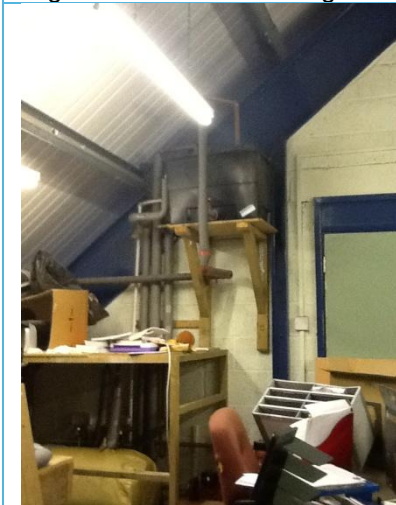
Img010: F&E Tank

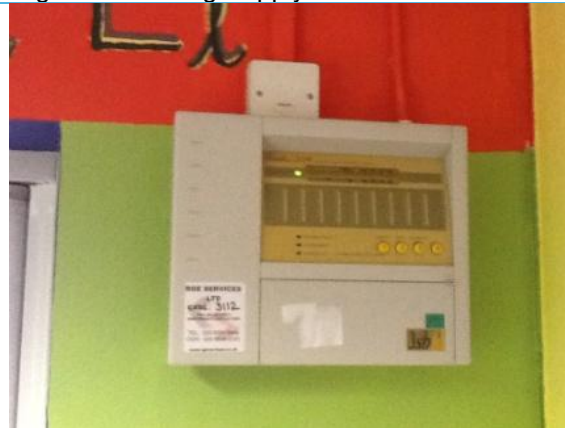
It could not be confirmed as part of the survey the intended category of the fire panel. Manual call points appeared sufficient throughout the building, however automatic detection was very sporadic.

Img011: Fire Panel

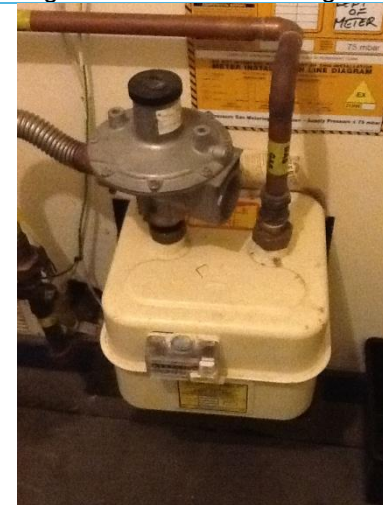
Img012: Gas Meter

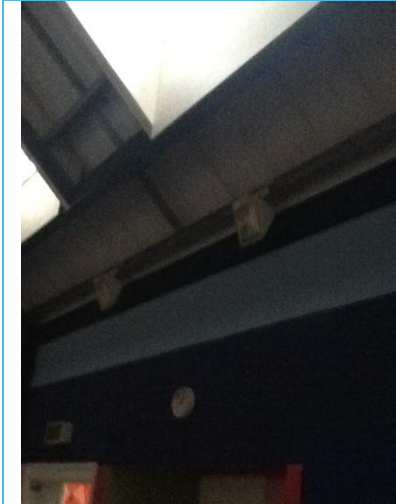
Additionally some of the lighting appears to have been installed by the previous tenants, with no evidence of supplementary testing.

Img013: Specialist Lighting

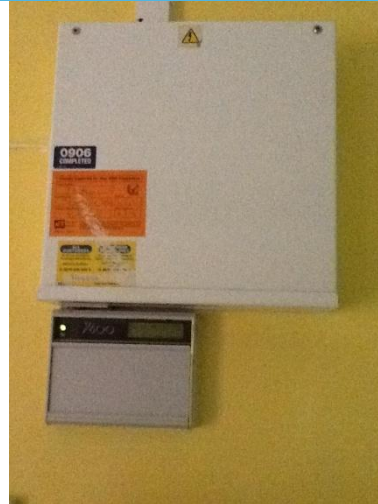
Element	Material	Location	Comments on defect	Remedial work	Condition Rating (A-D)	Priority Rating (1-4)	Cost	Photo
Security Systems	Intruder Alarms	Throughout	The main intruder alarm panel is located in the ground floor office. At the time of the survey the system did not appear to be in fault, however a test was not possible	None	B	3		014

Img014: Intruder Panel

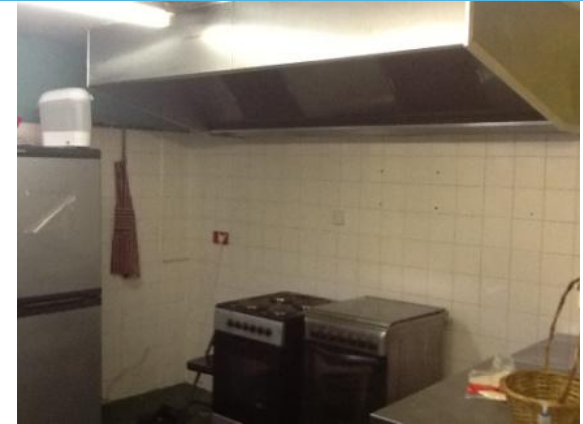
However the kitchen canopy appeared to be in reasonable order.

Img015: Kitchen Canopy

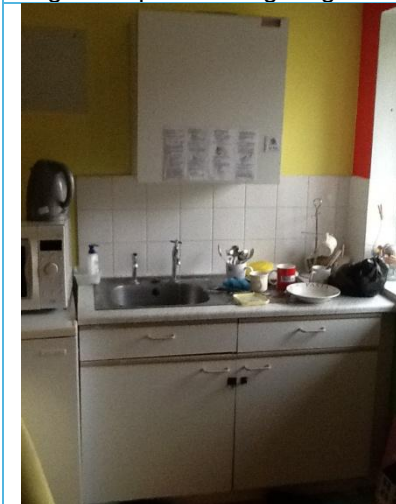
Element	Material	Location	Comments on defect	Remedial work	Condition Rating (A-D)	Priority Rating (1-4)	Cost	Photo
Sanitary – fittings	Kitchenette	Staff Room	Sink tap within the staff room is continually running and needs immediate attention	Repair Tap	B	1	£ 500.00	016
Sanitary – fittings	Toilets	Toilet Areas	Some of the toilet areas appear to have been used for storage. As such the units should be considered infrequently used and pose a legionella risk	Locally isolate and drain or put a legionella management process in place to prevent the legionella risk	D	1	£ 4,000.00	022
Sanitary – fittings	WC/basin/urinals	Various	All appeared mechanically sound with only evidence of historic leaking	None	B	4		
Sanitary – fittings	Kitchen	Kitchen	All appeared mechanically sound with only evidence of historic leaking	None	B	4		
HTG/CLG Source & Plant	F&E Tank	1 st Floor Plant Room	F&E Tank servicing the LTHW system. Appears mechanically sound, no means of internal inspection	None	A	4		010

Img016: Sink with leaking tap

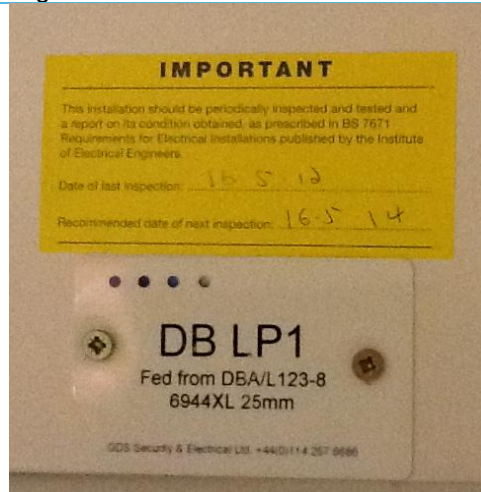
Img017: Evidence of Electrical T&I

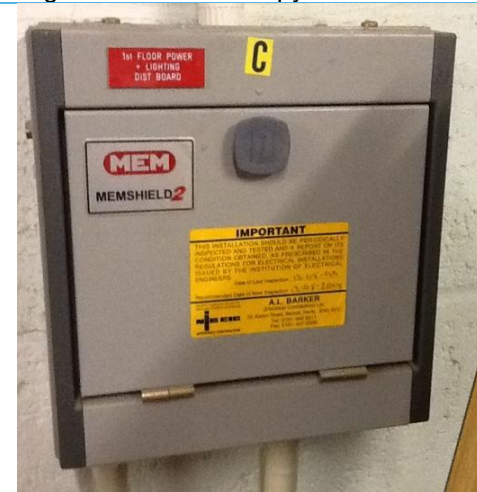
The distribution boards appeared to have had a valid test and inspection carried out, however the plant room distribution board in the plant room had not been tested at the same time.

Img018: 1st Floor Plant Room DB

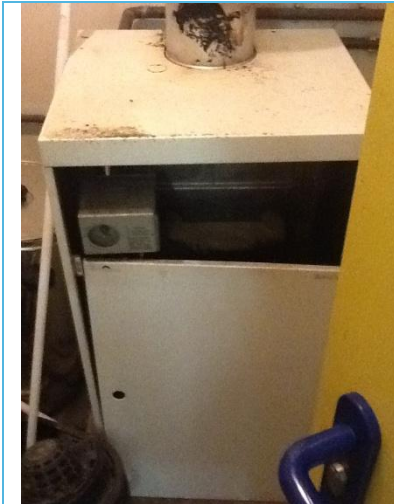
At the time of the survey neither boiler was in service, nor were service records available.

Element	Material	Location	Comments on defect	Remedial work	Condition Rating (A-D)	Priority Rating (1-4)	Cost	Photo
HTG/CLG Source & Plant	Primary Boiler	Ground Floor Plant Room	Boiler was not in service at time of survey, and no service documentation was available.	Immediate boiler service and safety inspection, however due to age and condition anticipate replacement required.	C	1	£ 42,000.00	019
HTG/CLG Source & Plant	Emitters and distribution	Throughout	Distribution pipework appears mechanically sound. Emitters are panel radiators with TRVs. Some radiators have been removed by persons and for reasons unknown.	Reinstate/Replace missing radiators	B	2	£ 4,000.00	020 021
HTG/CLG Source & Plant	Secondary Boiler (DHWS)	Ground Floor Plant Room	Boiler was not in service at time of survey, and no service documentation was available.	Immediate boiler service and safety inspection, however due to age and condition anticipate some remedial works.	B	3	£ 8,000.00

Img019: Primary Boiler

Due to the age and outward condition of the boilers it is recommended these boilers are changed.

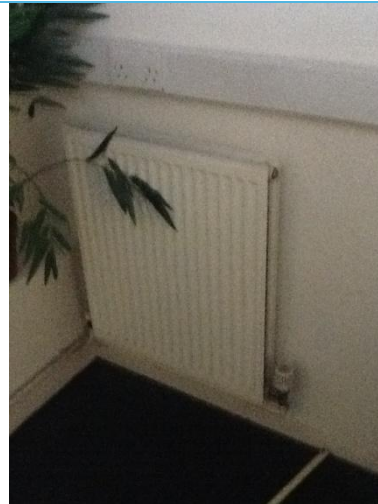
Img020: Typical Radiator

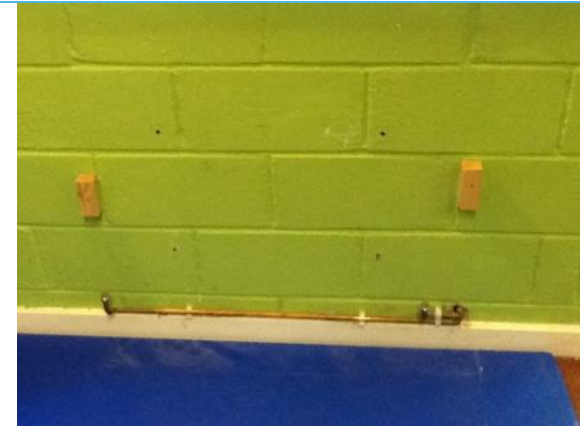
LTHW heating is provided by panel radiators. These appeared mechanically sound, however a number had been removed by others and the pipework capped. The reason for this removal is not known nor is the effect on the rest of the system.

Img021: Removed Radiator

If this system is to be retained, the system should be either rebalanced, or the removed radiators reinstated.

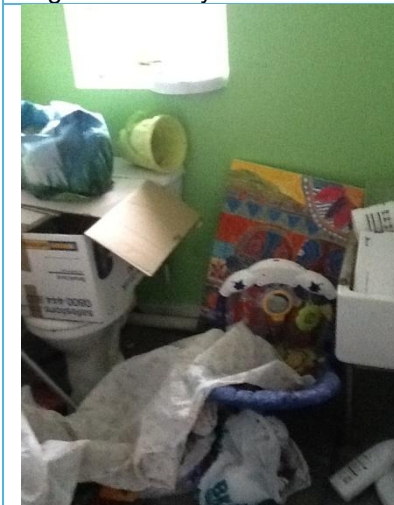
Img022: Toilet area used as store
