Cherry Tree Wood Pavilion. East Finchley

Comment on Condition.
September 2016

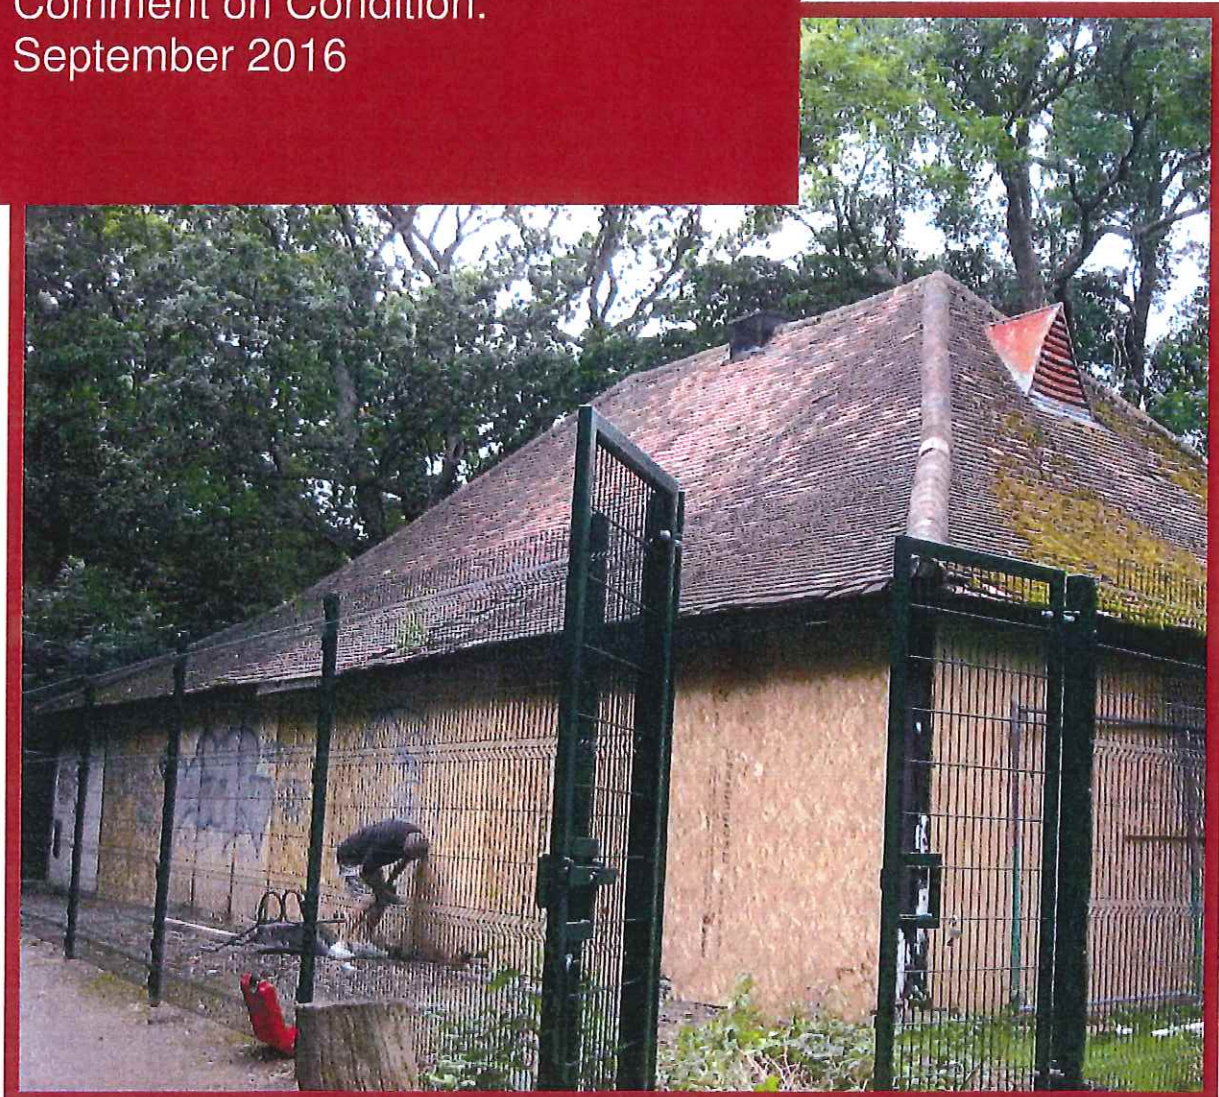
Brief Comment on Condition

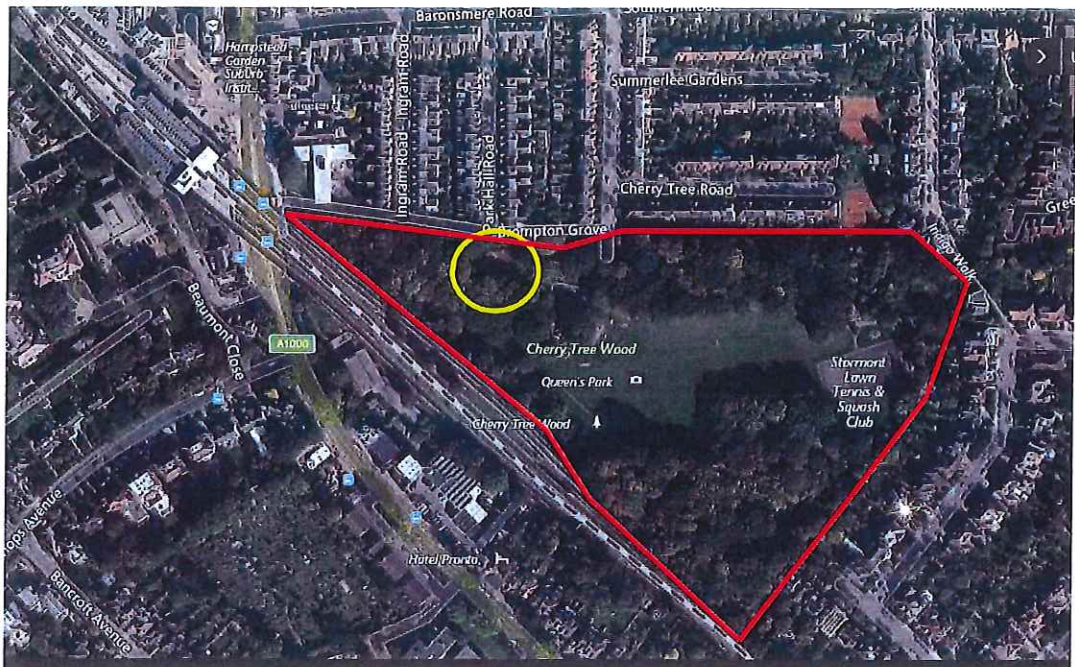
Fig 1. Shows park boundary (Red Line), Pavilion location circled yellow.

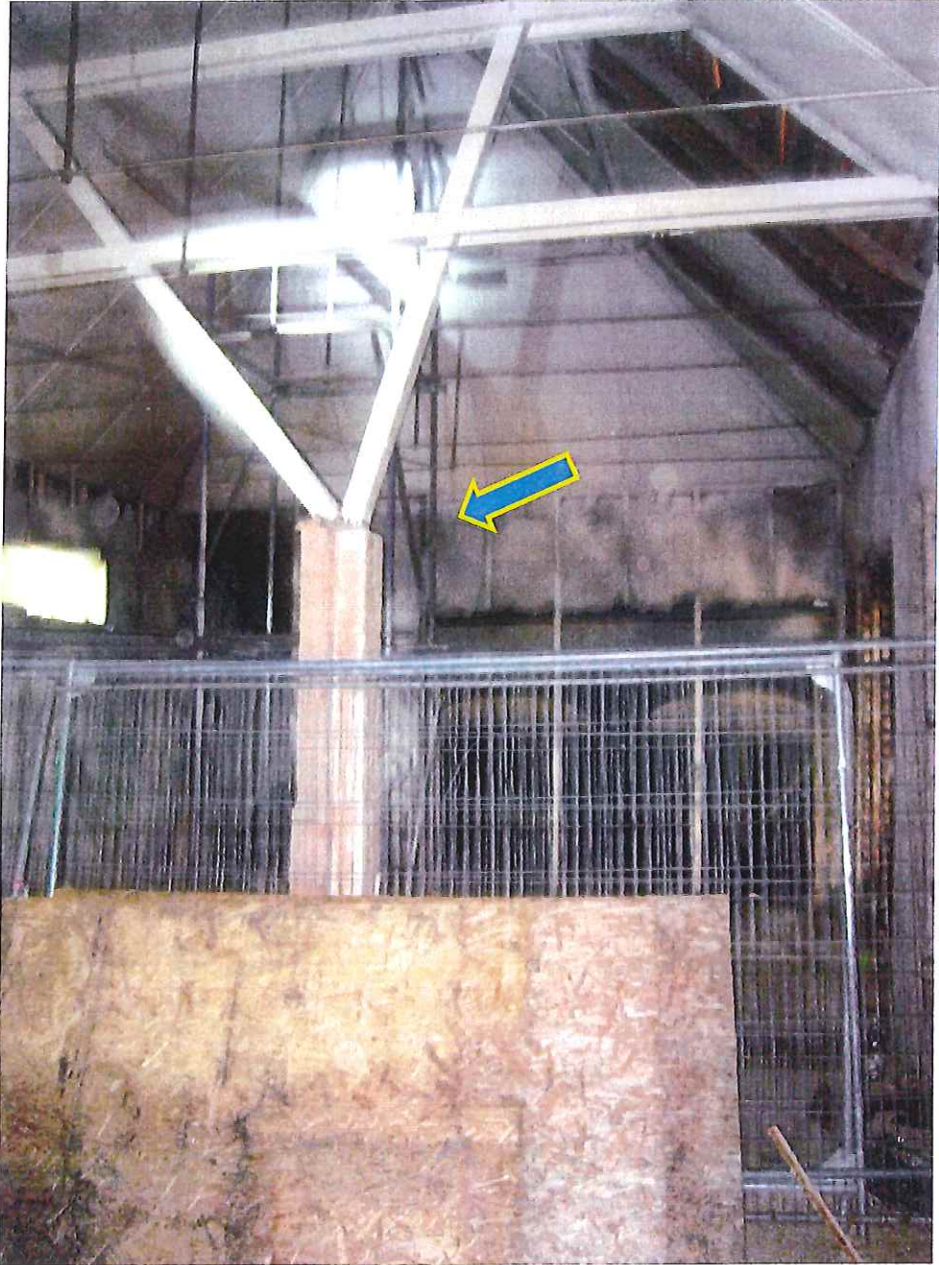
Fig 4. View of central brick pillar with main roof truss members sat on top.

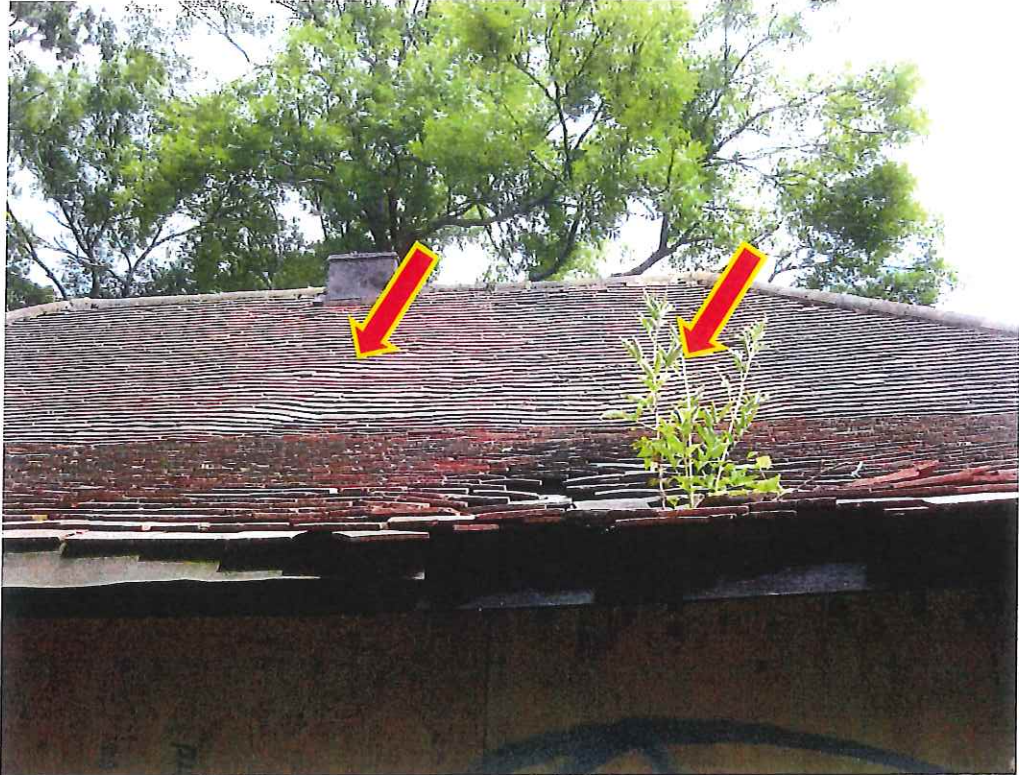
Fig 5. View of roof from front of the building, note the areas sagging caused by decay and lack of appropriate support.

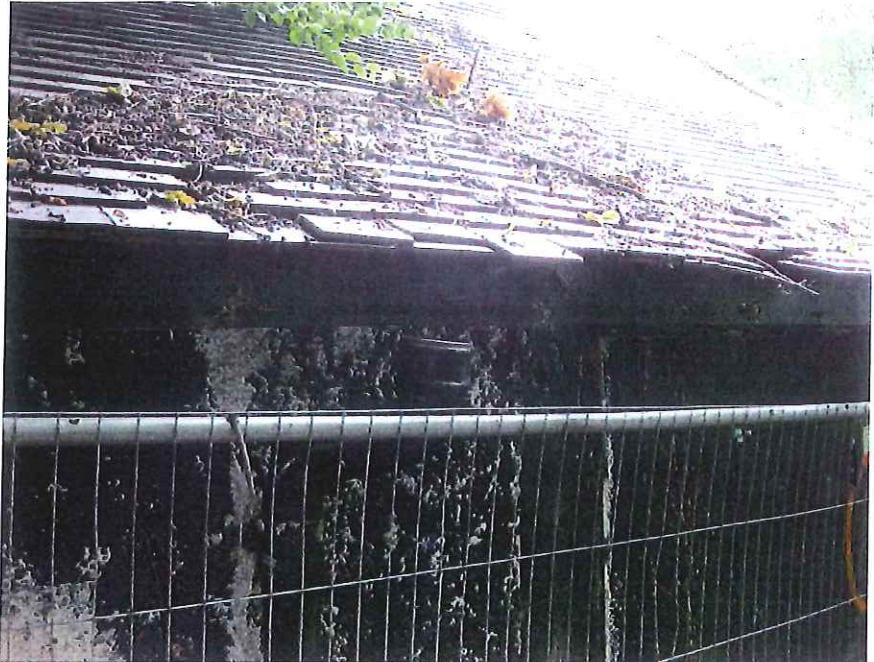
Fig 6. View of roof from side of the building, note the areas sagging caused by decay and lack of appropriate support.

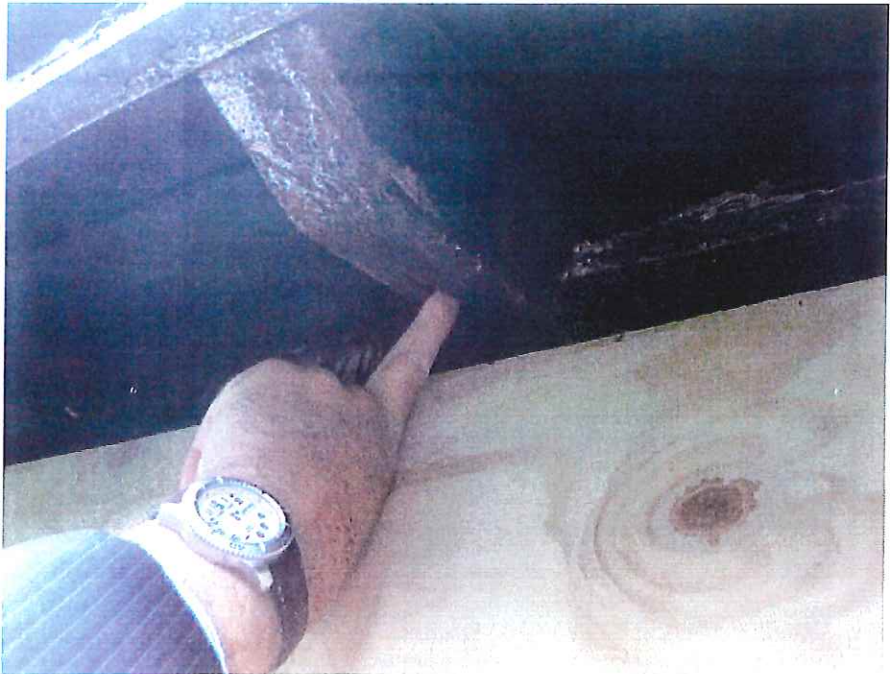
Fig 7. View of severely decayed rafters.

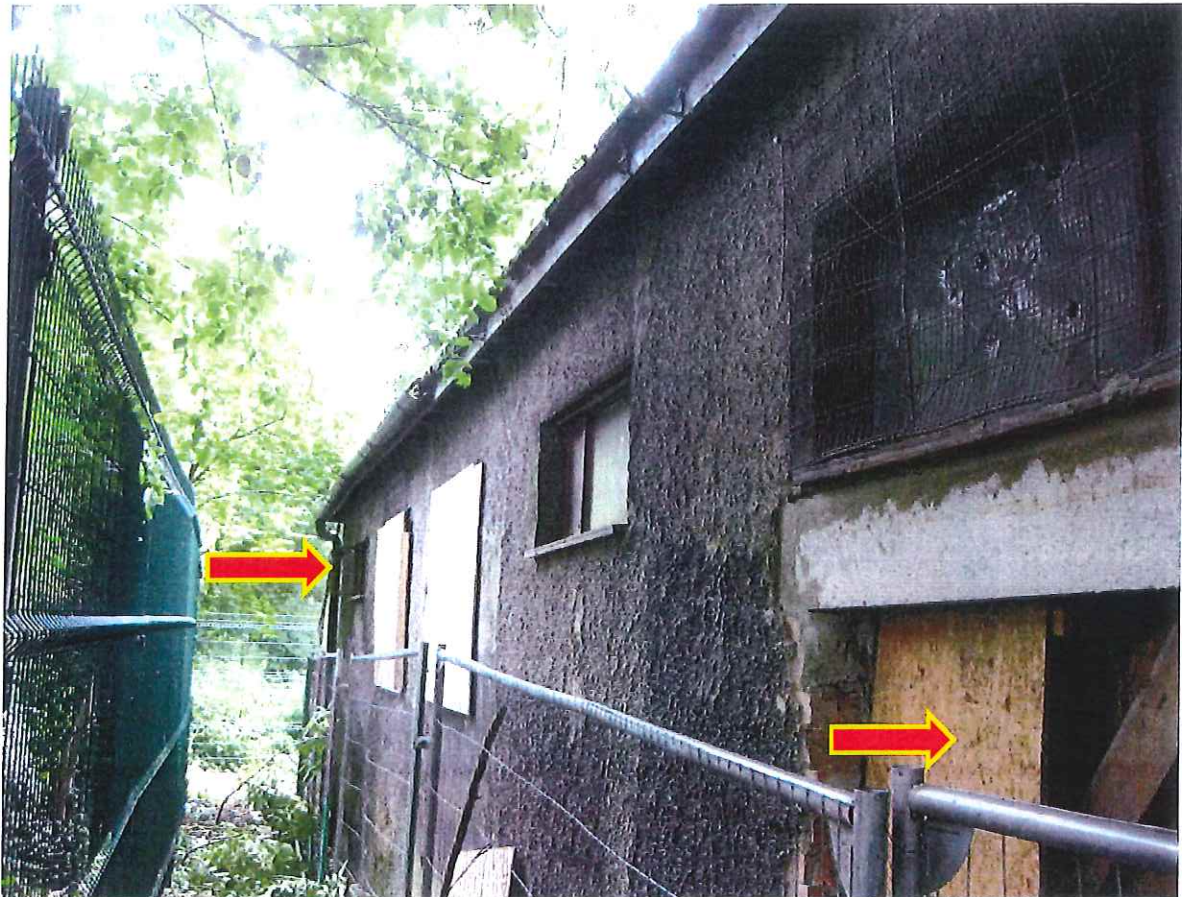
Fig 7. Rear of building insecure. Hole knocked in rear wall by existing tenant and window removed.

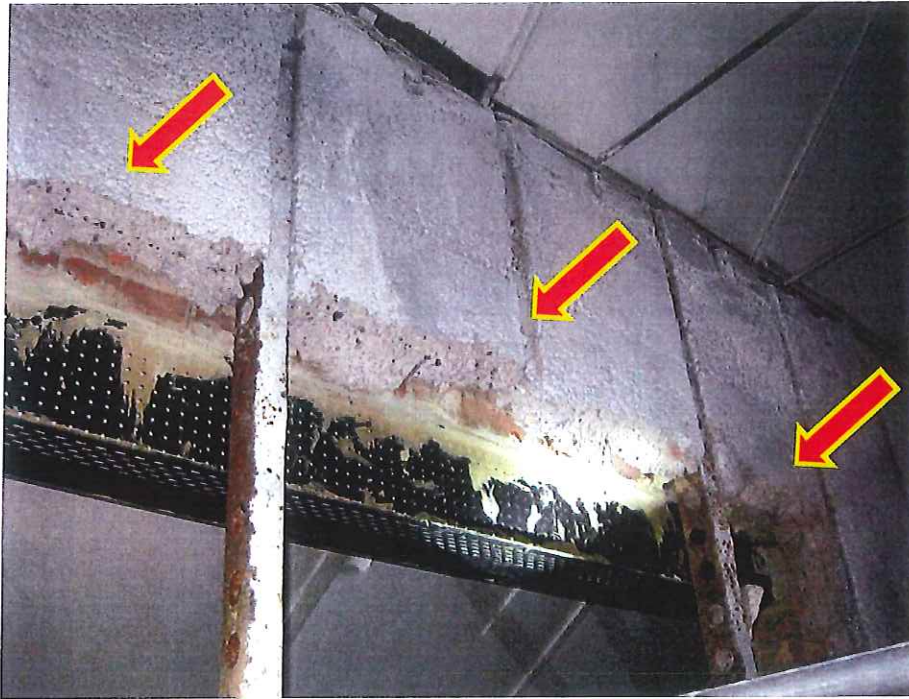
Fig 9. Unsupported concrete panels between corroded metal studs could collapse. This is typical of several locations.

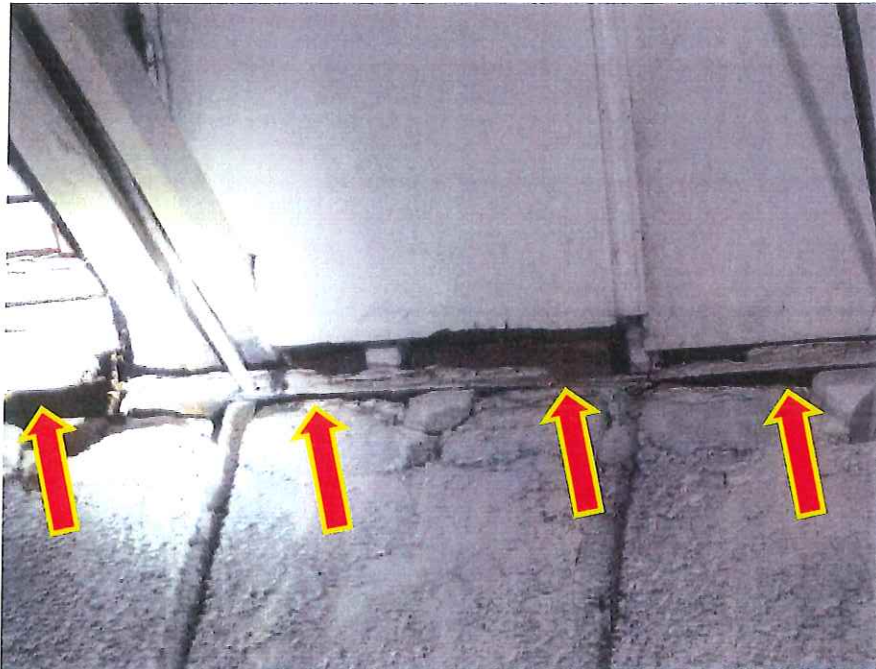
Fig 10. Timber wall plate and rafters decaying, this is typical of most areas at eaves level and in other areas.

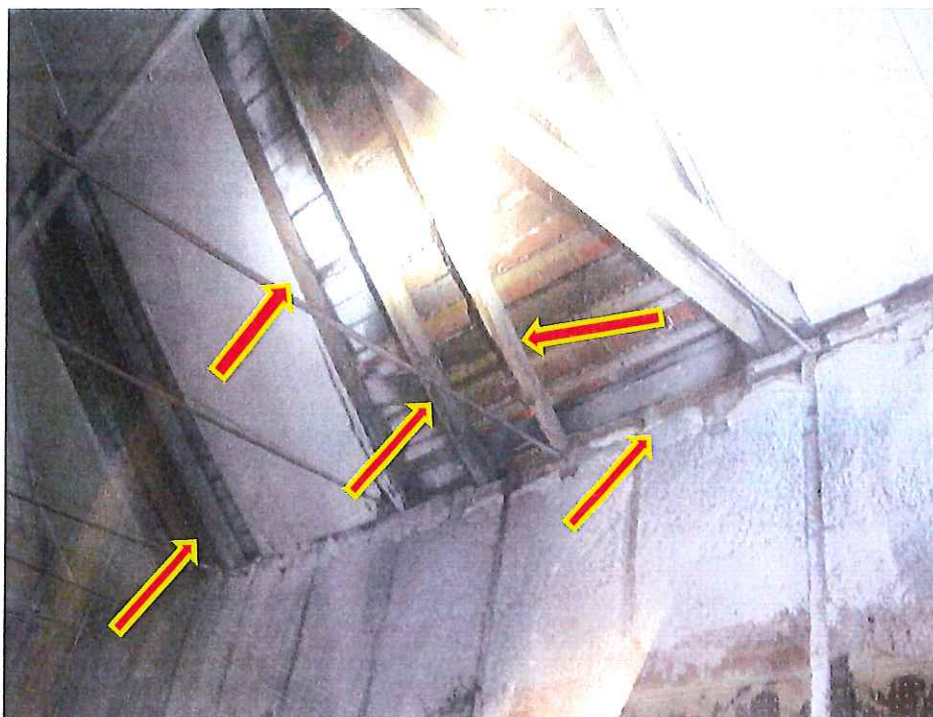
Fig 11. Timber wall plate and rafters decaying, this is typical of most areas at eaves level and in other areas.

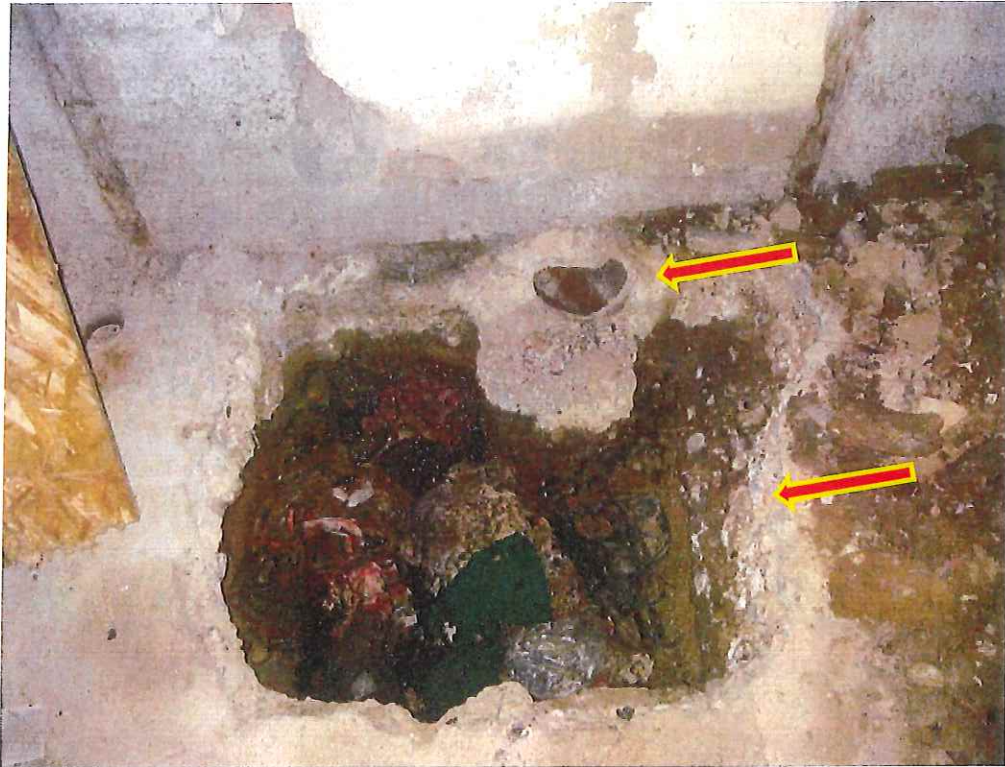
Fig 12. There are several holes in the floor. The holes appear to be trial pits to check out ground conditions below the concrete floor slab. There are also open drainage connections within the building.
