Cluster 1 BALLARDS LANE J/W NETHER STREET

Facts presented to March 2012 committee

Nether Street Width Restriction

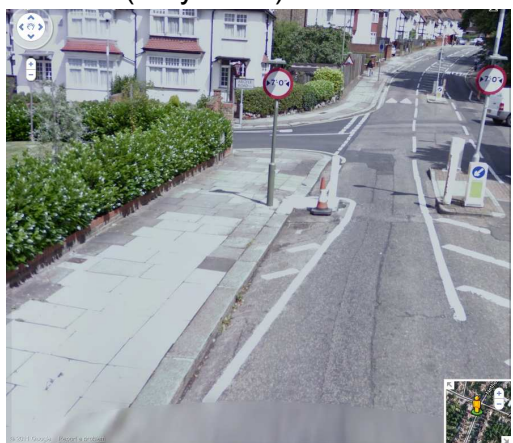
'Before' (May 2008) - Photo1

1. The adjustments made since, as borne in the 'before' and 'after' pictures, appear to have resulted in a less effective environment in terms of challenging a driver's normal perception of the street surroundings.
2. As a result the number of drivers who exercise due caution has diminished and this is borne by the 'spike' in incidents involving 'vehicle to barrier' collisions.
3. Concerns have been raised by residents, ward members and the Police regarding the incidents although the Police have expressed support for the restriction to stay.

- Prior to removal, the technique appeared to exist at the location through use of edge markings to visually narrow the road and presumably 'reduced' speeds. A comparison of accidents before and after the changes appears to lend weight to this assumption.

- Reinstate the hatching as per original reduced length / steep taper gradient as per **Photo 1**
- Re-introduce the edge lining and previous profile around the LHS post as per **Photo 1**

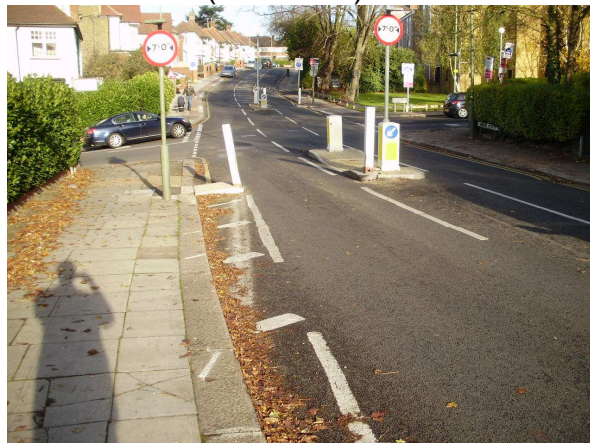
'After' (Nov 2011) – Photo2

1. LHS post now in line with kerb as opposed to being slightly set back.
2. Post-to-post (**kerb-to-kerb**) widths are as follows;
 - a. NB = 2.30m = 7' 6¹/₂" (**2.15m = 7' 3³/₅"**). This post-to-post clearance is slightly more generous than what it was during the survey of 10/10/2007 at 7' 3³/₄".
 - b. SB = 2.38m = 7' 9⁷/₁₀" (**2.11m = 6' 11¹/₁₃"**). This post-to-post clearance is slightly more generous than what it was during the survey of 10/10/2007 at 7' 6¹/₂".
3. 'Before' and 'after' photos (photo 1 & 2 respectively) appear to suggest hatching pattern and edge lining has been changed. The current hatch gives a longer taper and therefore much gentler 'chicane' effect whereas before it was steeper and arguably conveyed a more 'hazardous' feel.
4. Speed humps on opposing carriageways have been removed.

4. While the objective of a width restriction is not to act as a speed reduction measure, based on site observations there is anecdotal evidence to suggest, and a reason to believe, that more northbound drivers now do not reduce their speed enough to be able to navigate safely through the restriction. 2 family sized cars were observed on 9.08.11 driving at speeds that were 'too fast' for conditions and both suffered damage to wing mirrors.

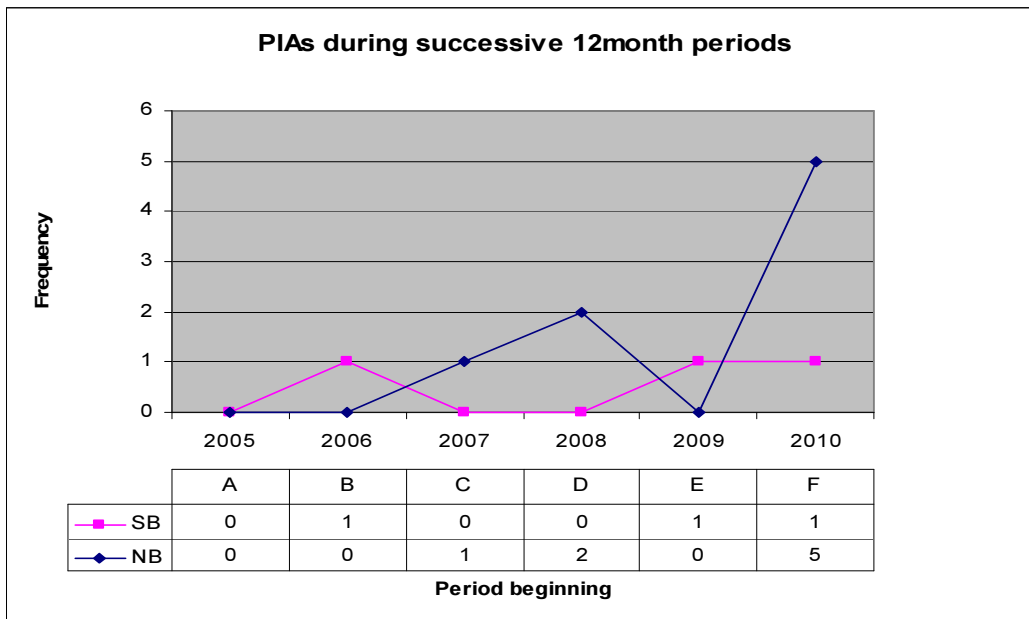
5. The problem appears to be confined to the northbound approach. A graphical representation of successive '12-month data' for recorded personal injury incidents involving cars hitting the barrier appears to confirm a link between the spike in incidents with the changes that have been made.

NB	SB
01/08/2005	<i>A</i>	0	0
01/08/2006	<i>B</i>	0	1
01/08/2007	<i>C</i>	1	0
01/08/2008	<i>D</i>	2	0
01/08/2009	<i>E</i>	0	1
01/08/2010	<i>F</i>	5	1
