Cromer Road, Barnet Local Safety Scheme Stage 1 Road Safety Audit

Project No: UV/009250-01

Document Reference: 33-19

Urban Vision Partnership Limited is instructed by Regional Enterprise Limited on behalf of the London Borough of Barnet to carry out a Stage 1 Road Safety Audit on the proposed 20mph and traffic calming options on Cromer Road, Shaftesbury Road and Bulwer Road in Barnet, London.

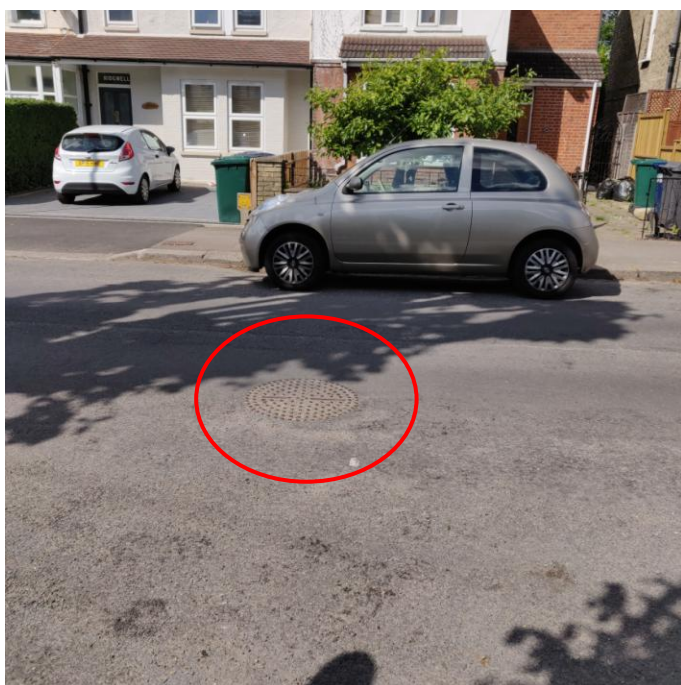
1 – Problem 2.2

Location: Shaftesbury Avenue (See Photo 1)

Summary: *Risk of loss of control type collisions*

It is proposed to locate a set of speed cushions on Shaftesbury Avenue outside property no. 8. During the site visit, the audit team noted an existing service cover in the carriageway at this location. There is concern that the co-location of the service cover and proposed speed cushion may cause difficulties during construction and become hazardous to motorists where there is a risk of loss of control type collisions.

Relocate the speed cushions away from the service cover on Shaftesbury Avenue.

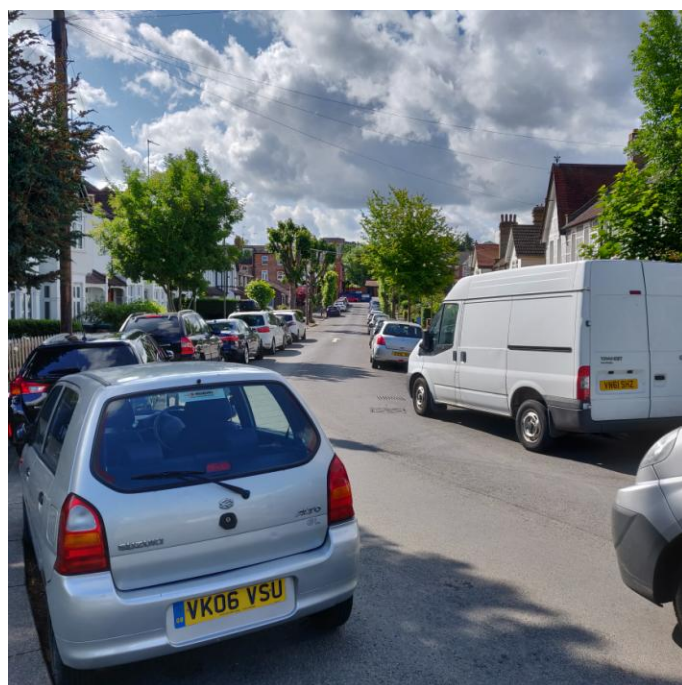
2 – Problem 2.3 and 2.4

Location: Throughout (See Photo 2, 3 and 4)

Summary: *Risk of personal injury to passengers.*

It was noted during the site visit that vehicles park along both sides of the one-way roads which forces moving traffic to travel down the centre of the carriageway. The audit team have concerns that motorists, particularly those in buses and emergency vehicles, will be unable to straddle the cushions as parked vehicles will force them to override the 'shoulders' of each cushion resulting in maximum discomfort to passengers, potentially causing injury. Repetitive, heavy loading on the shoulders of the cushions will also cause damage over time, reducing their effectiveness in maintaining low vehicle speeds.

Summary: *Risk of speed related collisions in future.*

Further to 2.3 above, when there are no vehicles parked adjacent to the cushions, there is potential for motorists to deviate from the centre of the carriageway towards the kerb to fully straddle the cushions where there is a risk of side-swipe type collisions with adjacent cyclists.

Ensure motorists are able to straddle the cushions without being forced to override the 'shoulders' due to adjacent parking.

Ensure motorists are able to straddle the cushions without any sudden deviation in their path.

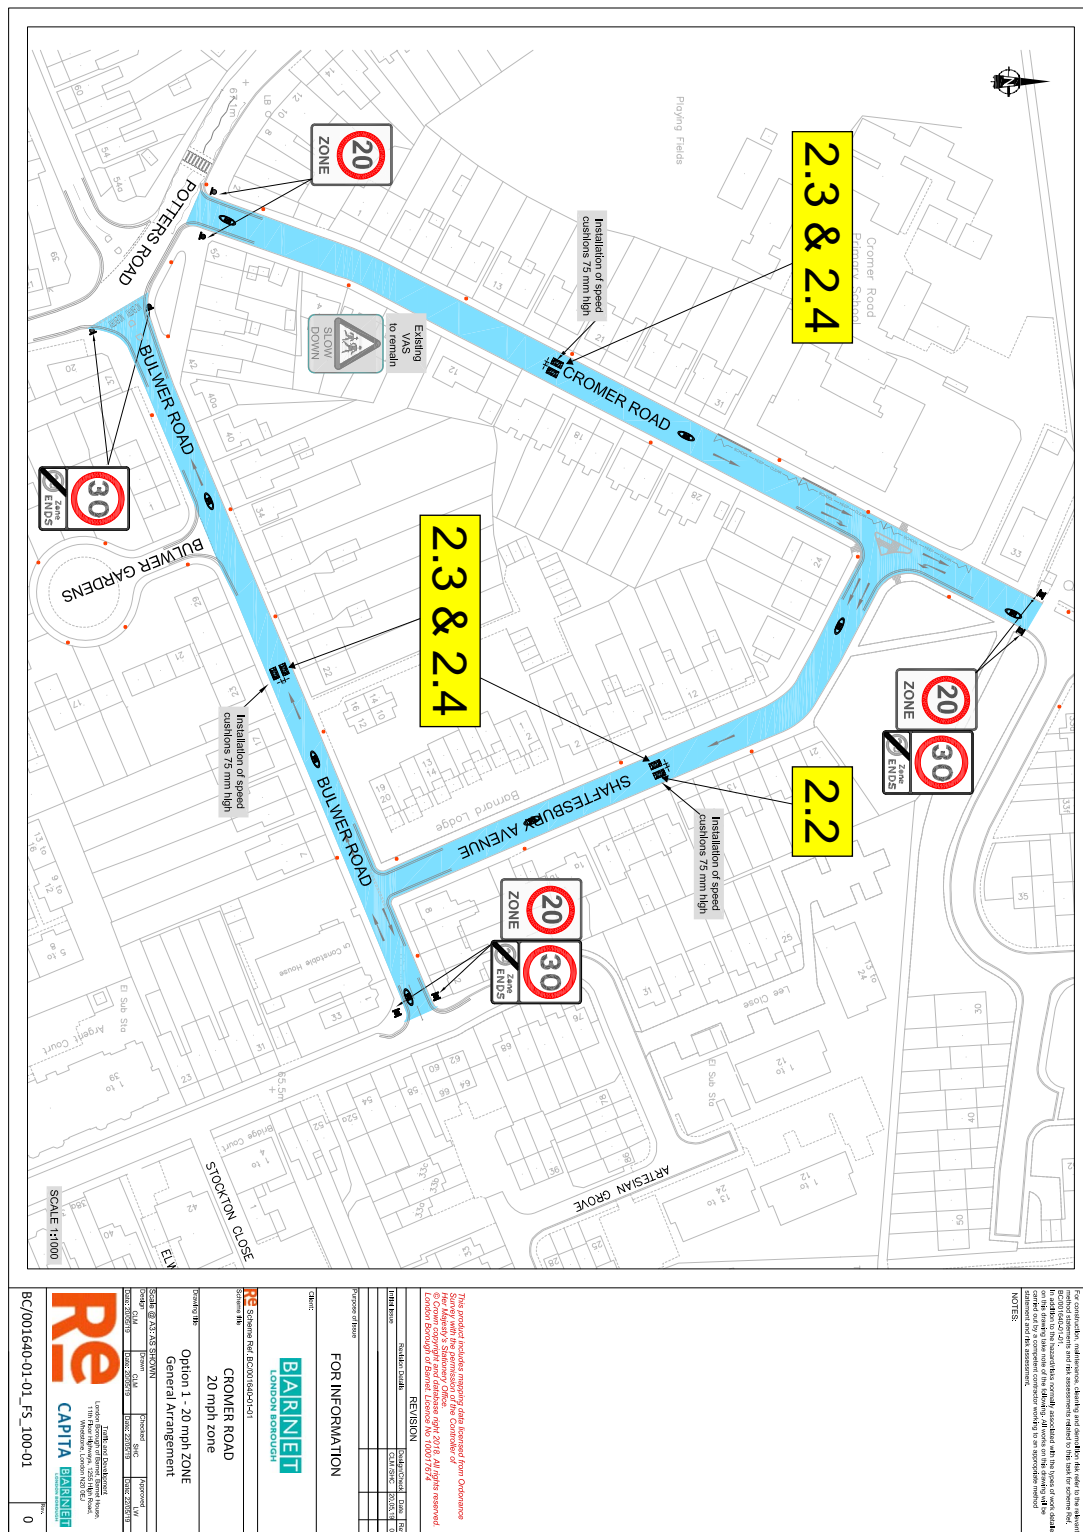
Appendix B Reference Plan Option 1

This audit will examine the two options proposed. Option 1 consists of a 20mph zone with speed cushions proposed on Cromer Road (Outside No. 19), Shaftesbury Avenue (Outside No. 8) and Bulwer Road (Outside Nos. 22/24) along with repeater 20mph roundel road markings. Meanwhile Option 2 consists of terminal 20/30 mph traffic signs and repeater 20mph roundel road markings only.

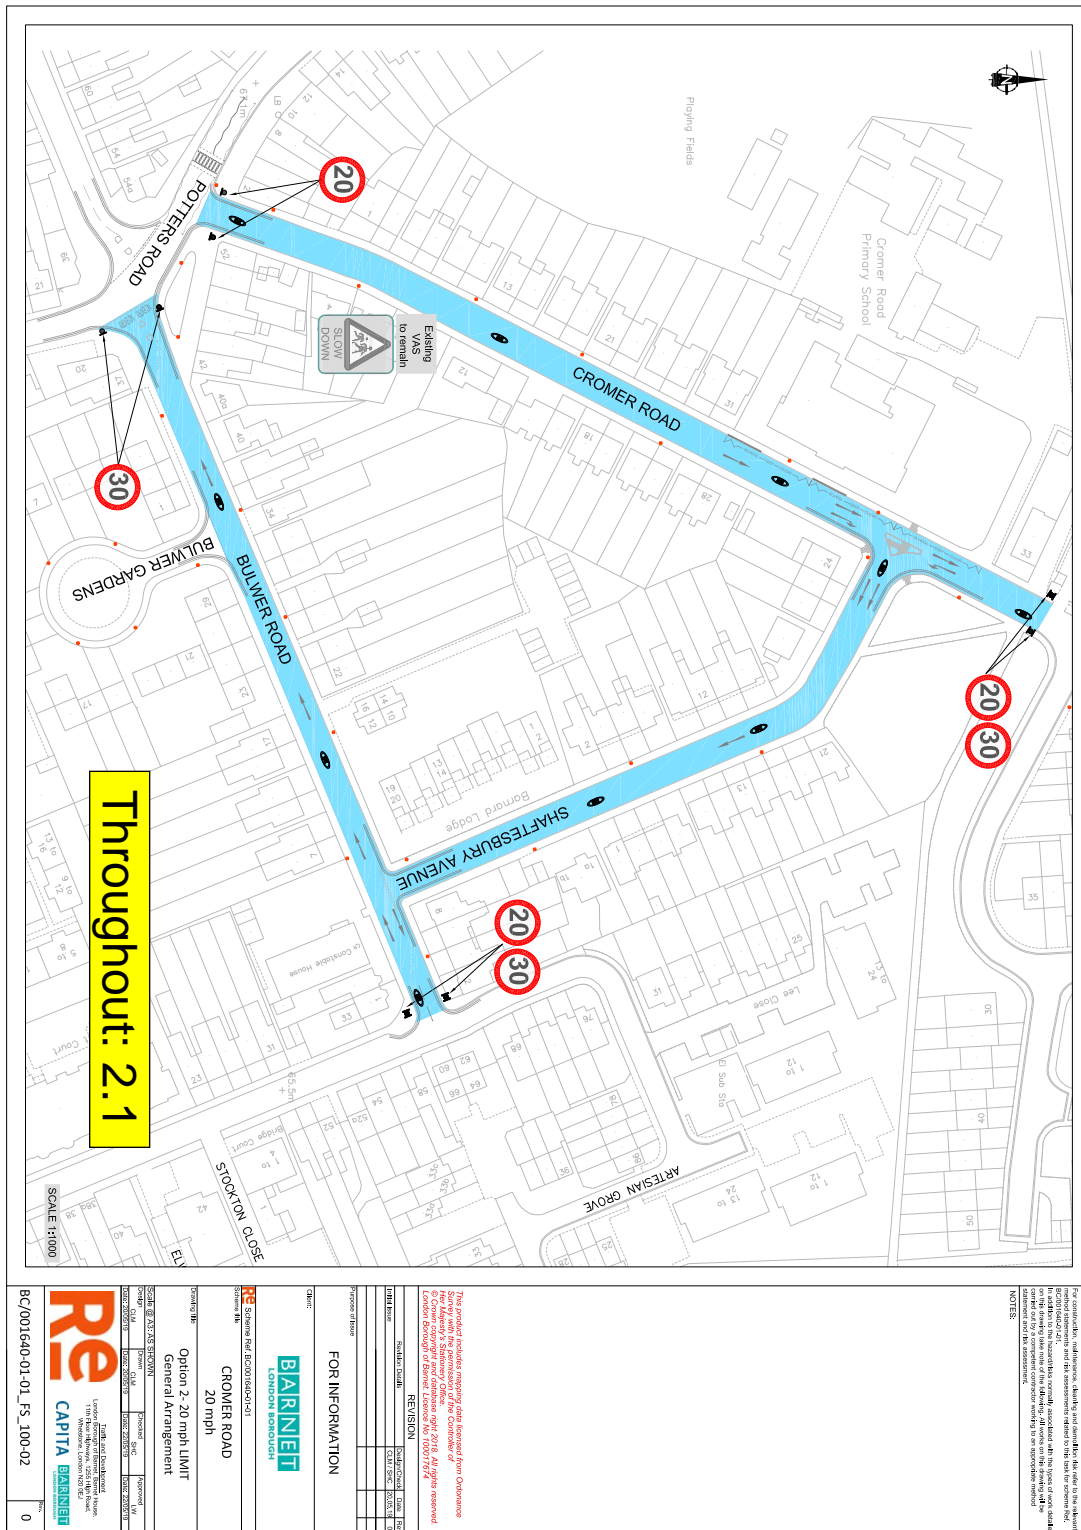
Appendix C Reference Plan Option 2

Summary: *Risk of speed related collisions.*

On review of the speed survey data, the average 85th percentile free flow speeds on each road where it is proposed to introduce a 20mph limit exceeds 24 mph. The audit team have concerns that traffic signs and repeater road markings alone would be ineffective in reducing speeds, particularly given the straight road layouts and one-way system. There is concern the 20mph proposals may provide a false sense of security to vulnerable road users who may attempt to cross more freely, leading to an increased risk of speed related collisions.

Provide physical speed reducing features at regular intervals to encourage better compliance with the 20mph speed limit.
