MEETING**CHIPPING BARNET AREA COMMITTEE****DATE AND TIME****WEDNESDAY 22ND OCTOBER, 2014****AT 7.00 PM****VENUE****1255 HIGH ROAD, WHETSTONE, N20 0EJ**

Title	Wellhouse Lane Pedestrian & Safety Improvements
Report of	Declan Hoare – Lead Commissioner for Housing and Environment
Wards	High Barnet
Status	Public
Enclosures	Appendix A: <i>Wellhouse Lane – Barnet Highway and Pedestrian Assessment Report of 31 March 2014.</i> Appendix B: <i>Drawing Nos. G/0/14-15, 17 & 18</i>
Officer Contact Details	Themba.Nleya, Senior Engineer – Traffic & Development, Themba.Nleya@Barnet.gov.uk , Telephone 0208 359 4198 Lisa Wright, Traffic & Development Manager Lisa.Wright@Barnet.gov.uk , Telephone 0208 359 3049

Wellhouse Lane - Barnet Highway and Pedestrian Assessment

31st March 2014

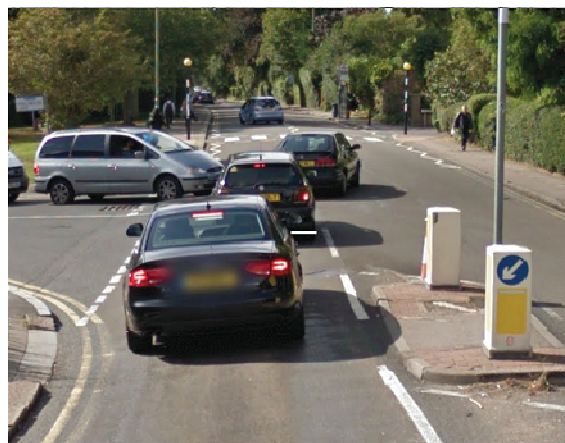
Fig 2.1 – Right Turning Traffic Edging out of Wellhouse Lane.

- 2.5 Apart from the zebra crossing, there are minimal delays to through traffic on Wood Street. However vehicles emerging from Wellhouse Lane experience difficulties due to the high traffic flow on the main road (Wood Street), this causes driver frustration with vehicles frequently edging out from the junction blocking Wood Street westbound traffic and the right turn lane (see Fig 2.1 below) as they wait an opportunity to merge with the eastbound traffic flow.

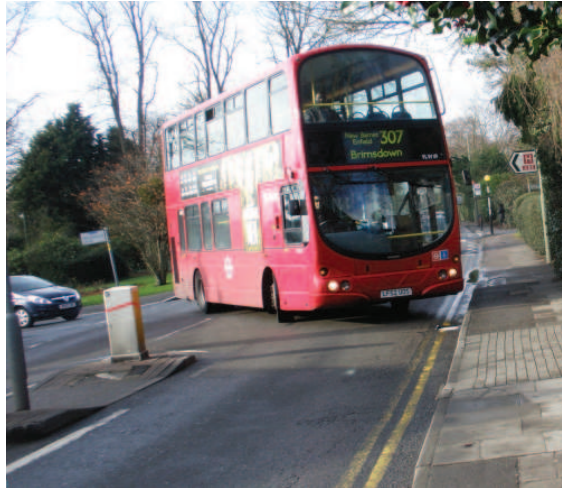
Fig 2.2 – Right Turning Bus out of Wellhouse Lane

- 2.7 It is noted that large vehicles, in particular buses, experience difficulties when turning right out of Wellhouse Lane due to the location of the existing traffic island on Wood Street. This often means that large vehicles either overhang or mount the opposite footway. (Fig 2.2 below)

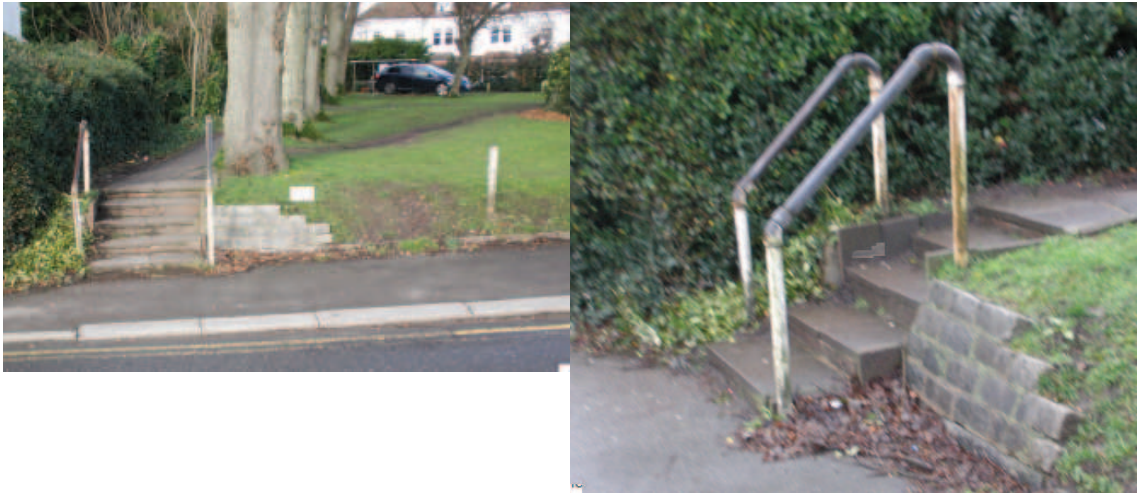
Fig 2.3 – Worn Grass Area and Poor Standard Steps

- 2.12 It is noted that pedestrian desire lines do not appear to match the footpaths in the vicinity of and across the green space, as seen by substantial wear on the grass itself. Pedestrians appear to frequently cross the grass area diagonally rather than stay on the surfaced footpaths, and are then faced by steps to the northern footway on Wellhouse Lane (fig 2.3). At this location the northern footway, on the eastern side of Wellhouse Lane, terminates and pedestrians are then required to cross Wellhouse Lane at that point or walk in a southbound direction on the carriageway, until there is a gap in the traffic to cross the road towards the hospital complex. It is noted that visibility to and for pedestrians here is obstructed by the hedge line fronting the private house (number 2) on Wellhouse Lane in that area, which overhangs the highway verge.

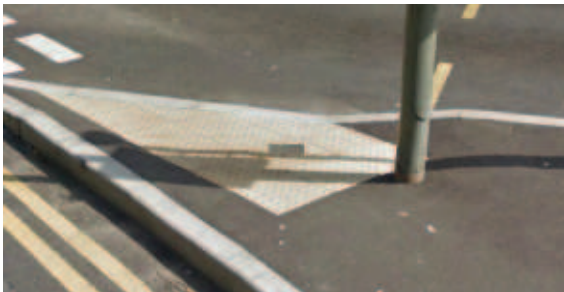
Fig 10.1 – Lighting Column Obstructing Pedestrian Movements on Wellhouse Lane

- 10.1 There are two recently installed / improved bus stops located on Wellhouse Lane in the vicinity of the hospital as a terminus. These are in good condition and serve around 200 buses in a 12 hour period. The two stops in the vicinity of the hospital are accessed via drop kerbs and tactile paving, as per the authorities standards. It is noted however that the one tactile paving installation directs pedestrians towards a lighting column. It is considered that this is unsafe for the visually impaired and while the area is located away from the junction being appraised, it is recommended that the said column is relocated. See Fig 10.1 below.

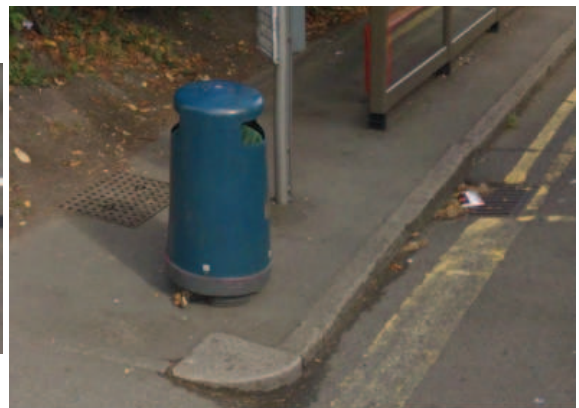
Fig 10.2 – Eastbound Bus Stop on Wood Street

- 10.3 From available photographs, both stops would benefit from enhancement of the bus cage road markings.
- 10.4 It is noted (as photo Fig 10.2 above) that the footway to the rear of the east bound stop is bordered by the adjacent properties garden and hedge line, where soil appears to spill onto the footway, this could create a slip hazard in wet weather within this narrow footway area. It is suggested that some kind of retaining structure (kerbs or edgings) be installed at the rear of the footway to prevent soil spillage and to highlight the footway boundary.

- 10.5 It is noted that passenger movements at the east bound bus stop are constrained by the shelter, bus flag post and litter bin, together with the adjacent driveway (photo above). It is considered that the bin and post could be relocated to ease passenger movements.

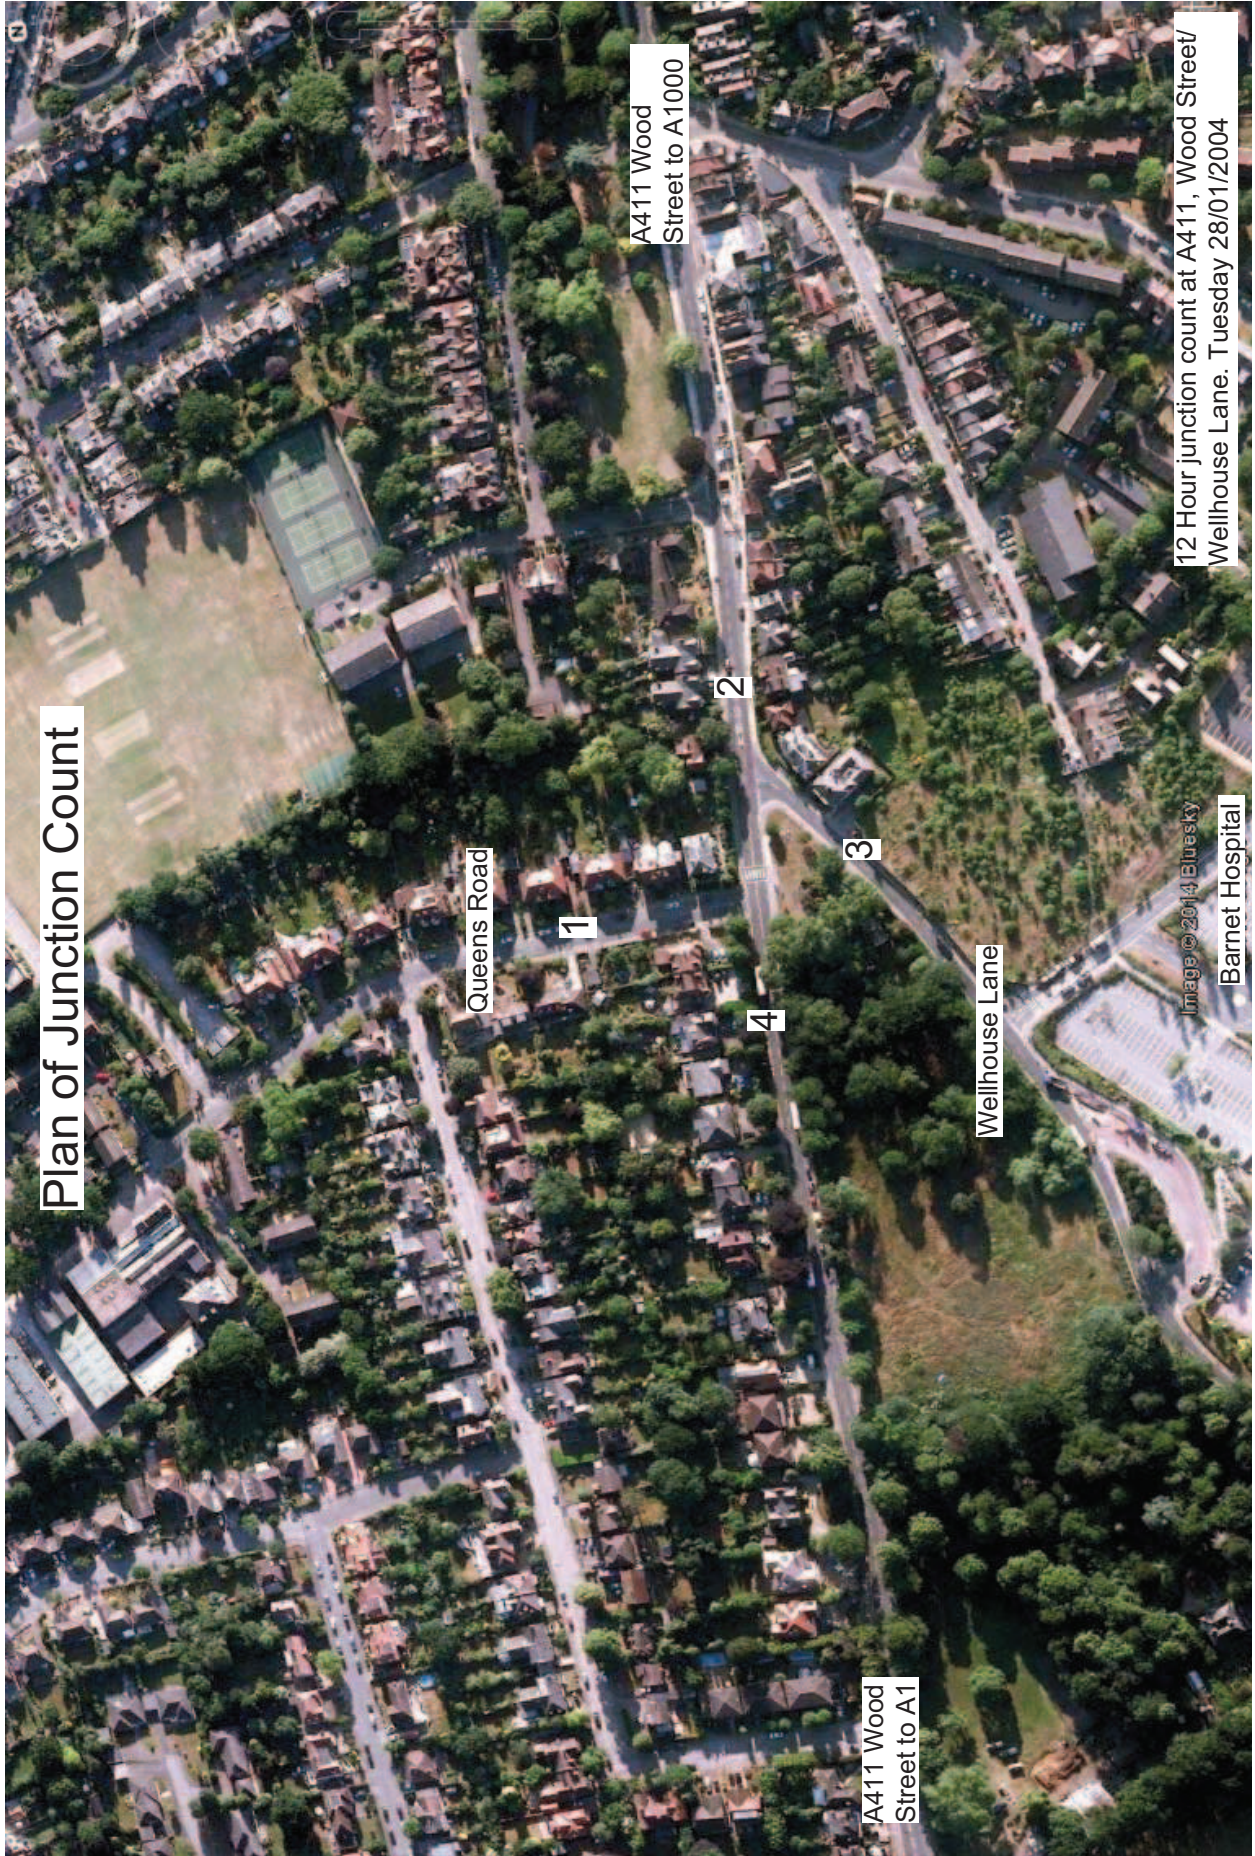
Plan of Junction Count

- 1 Queens Road
- 2 A411 Wood Road (East)
- 3 Wellhouse Lane
- 4 A411 Wood Road (West)

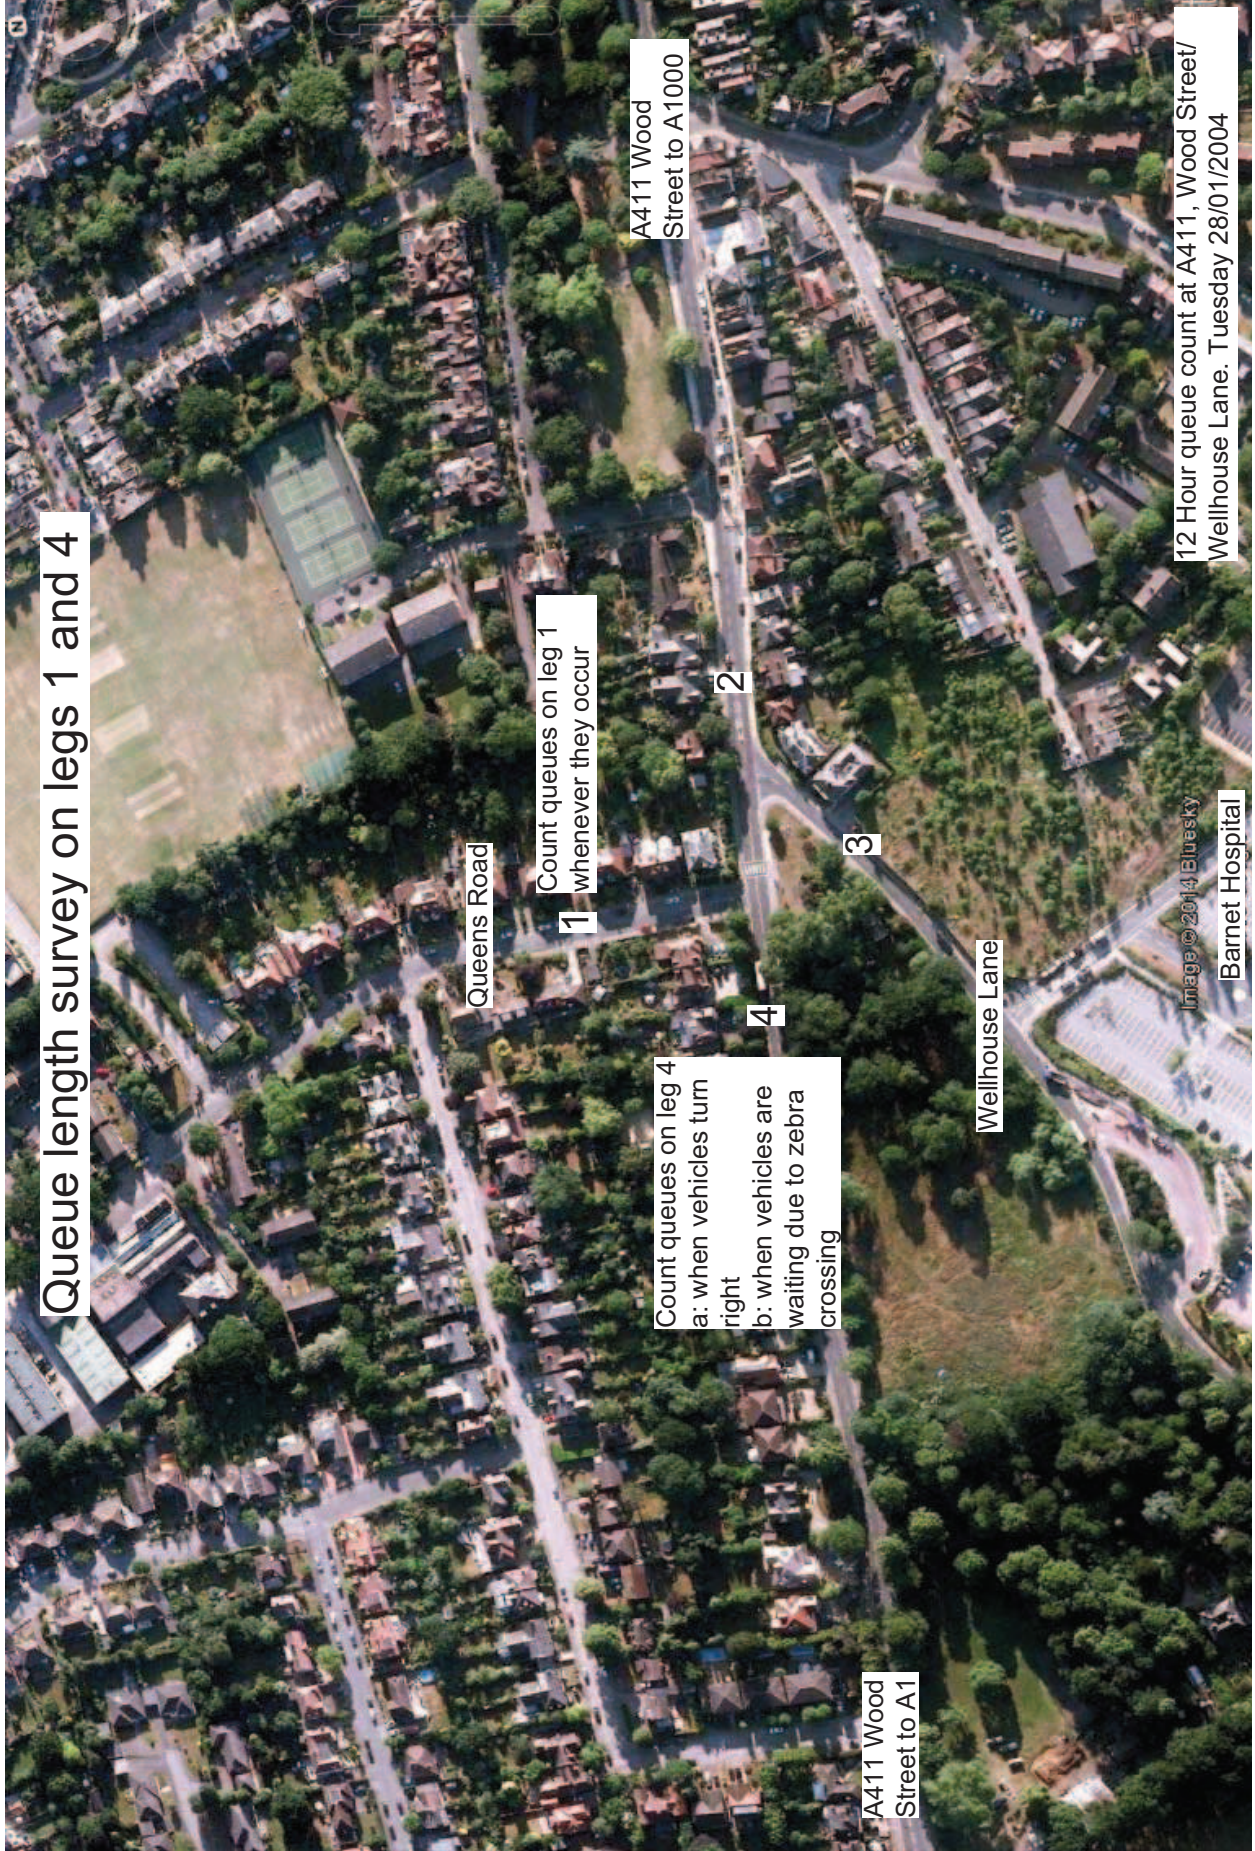
Queue length survey on legs 1 and 4

1 Count queues on leg 1 whenever they occur

Count queues on leg 4
a: when vehicles turn right
b: when vehicles are waiting due to zebra crossing

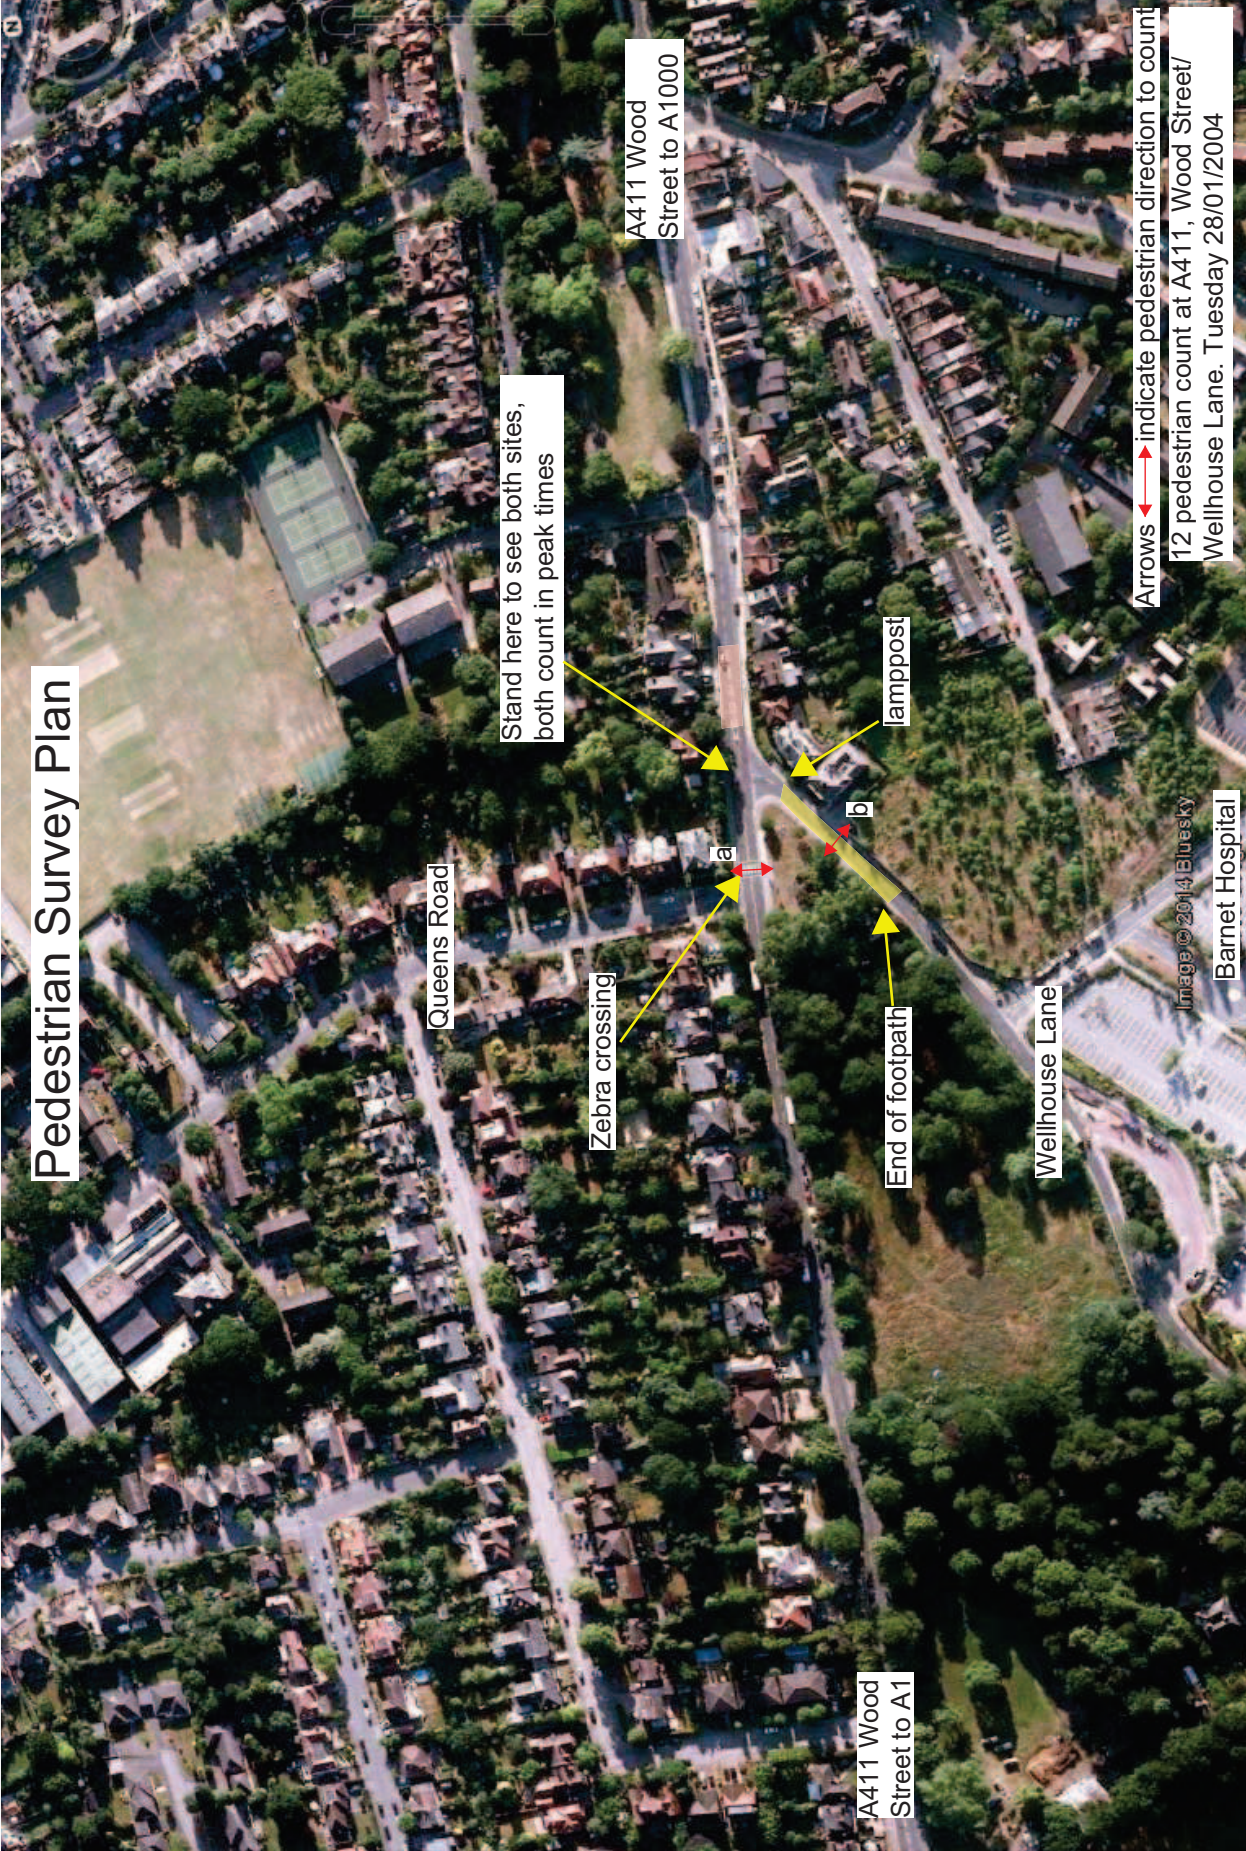
Pedestrian Survey Plan

A411 Wood Street to A1000

Stand here to see both sites, both count in peak times

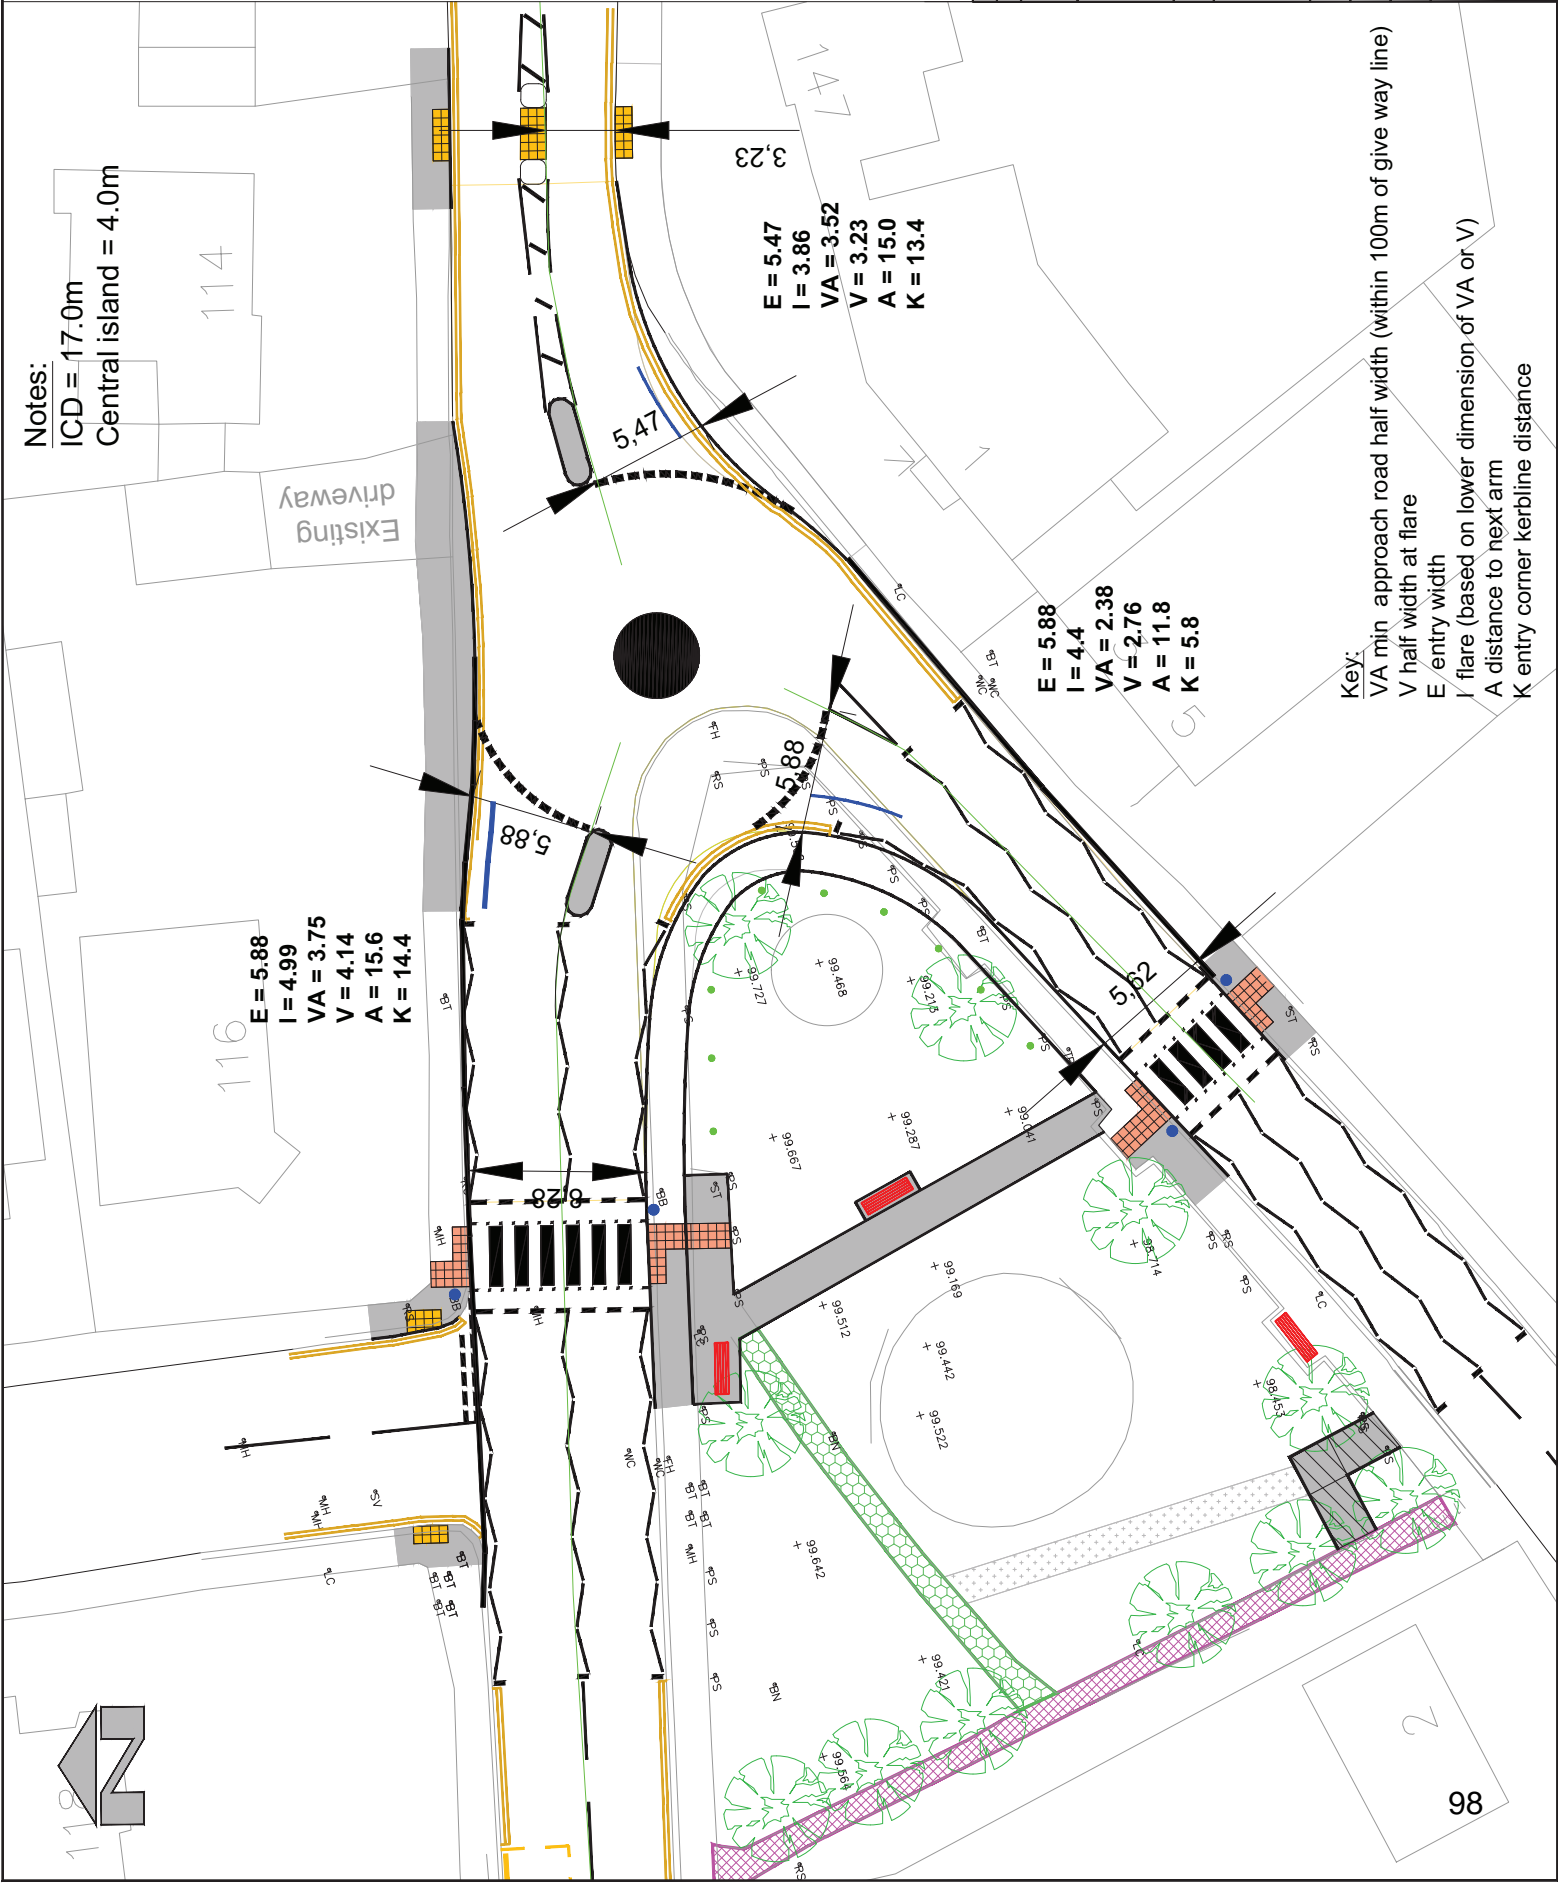
Notes:
ICD = 17.0m
Central island = 4.0m

E = 5.88
I = 4.99
VA = 3.75
V = 4.14
A = 15.6
K = 14.4

E = 5.47
I = 3.86
VA = 3.52
V = 3.23
A = 15.0
K = 13.4

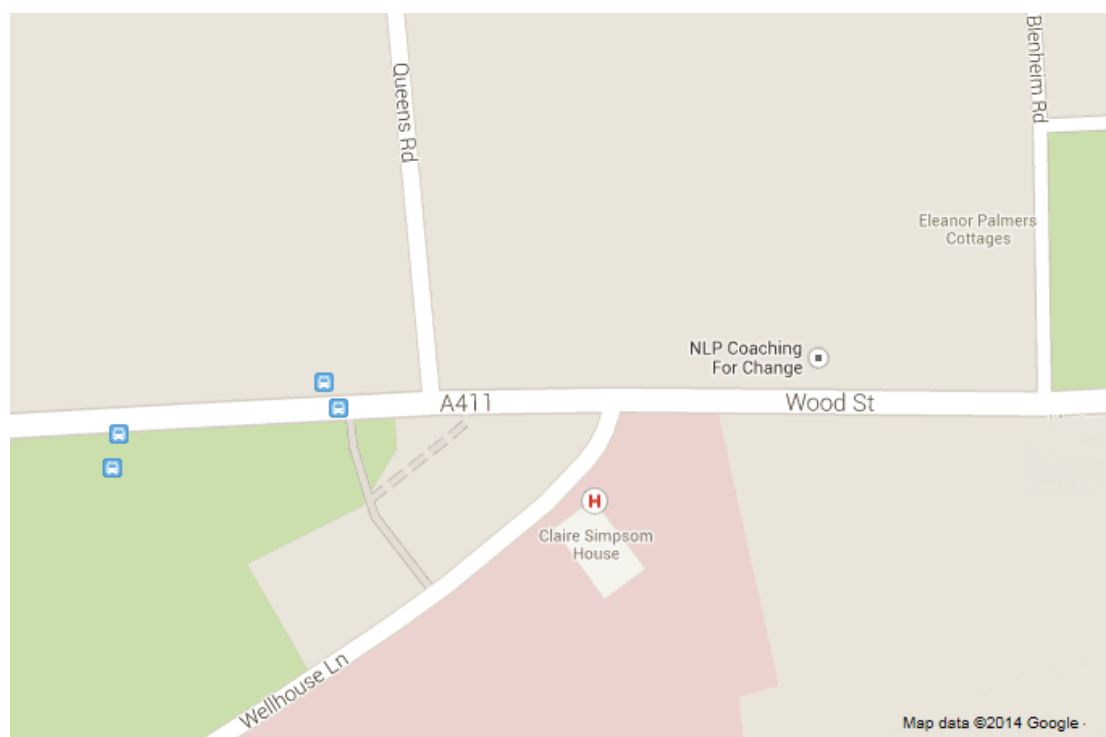
Figure 1 Site Location Plan

Capita were commissioned to undertake a LinSig analysis to establish the effects of signalling the junction of A411/Wellhouse Lane. The junction is in the London Borough of Barnet. Nearby is the junction of A411/Queens Road, as can be seen in **Fig. 1**.

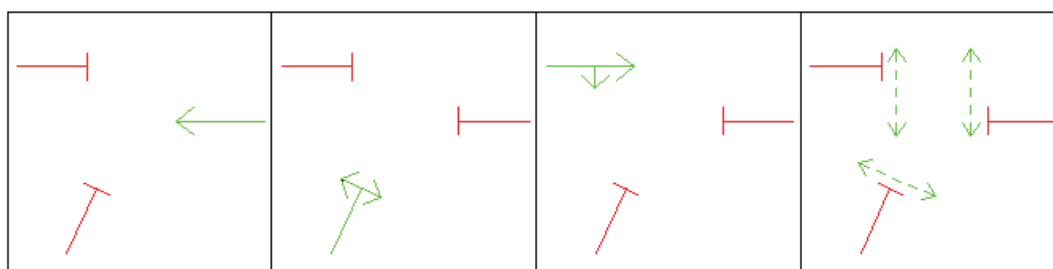
- Option 1: 4 Stage Junction (Unopposed Right Turn)

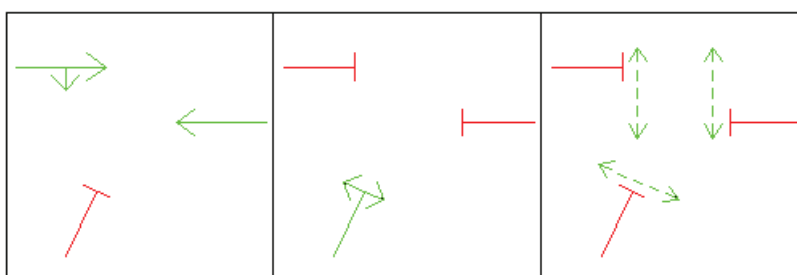
- Option 2: 3 Stage Junction (Right Turners Give Way without storage lane)

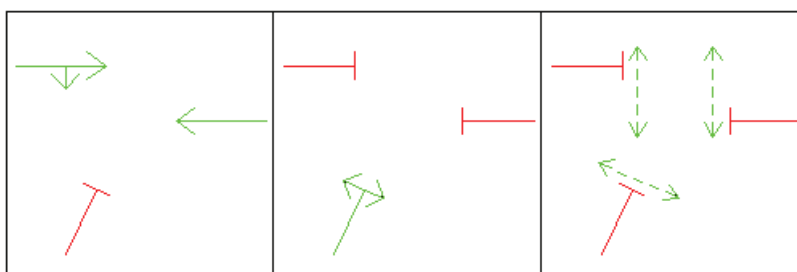
- Option 3: 3 Stage Junction (Right Turners Give Way with short storage lane)

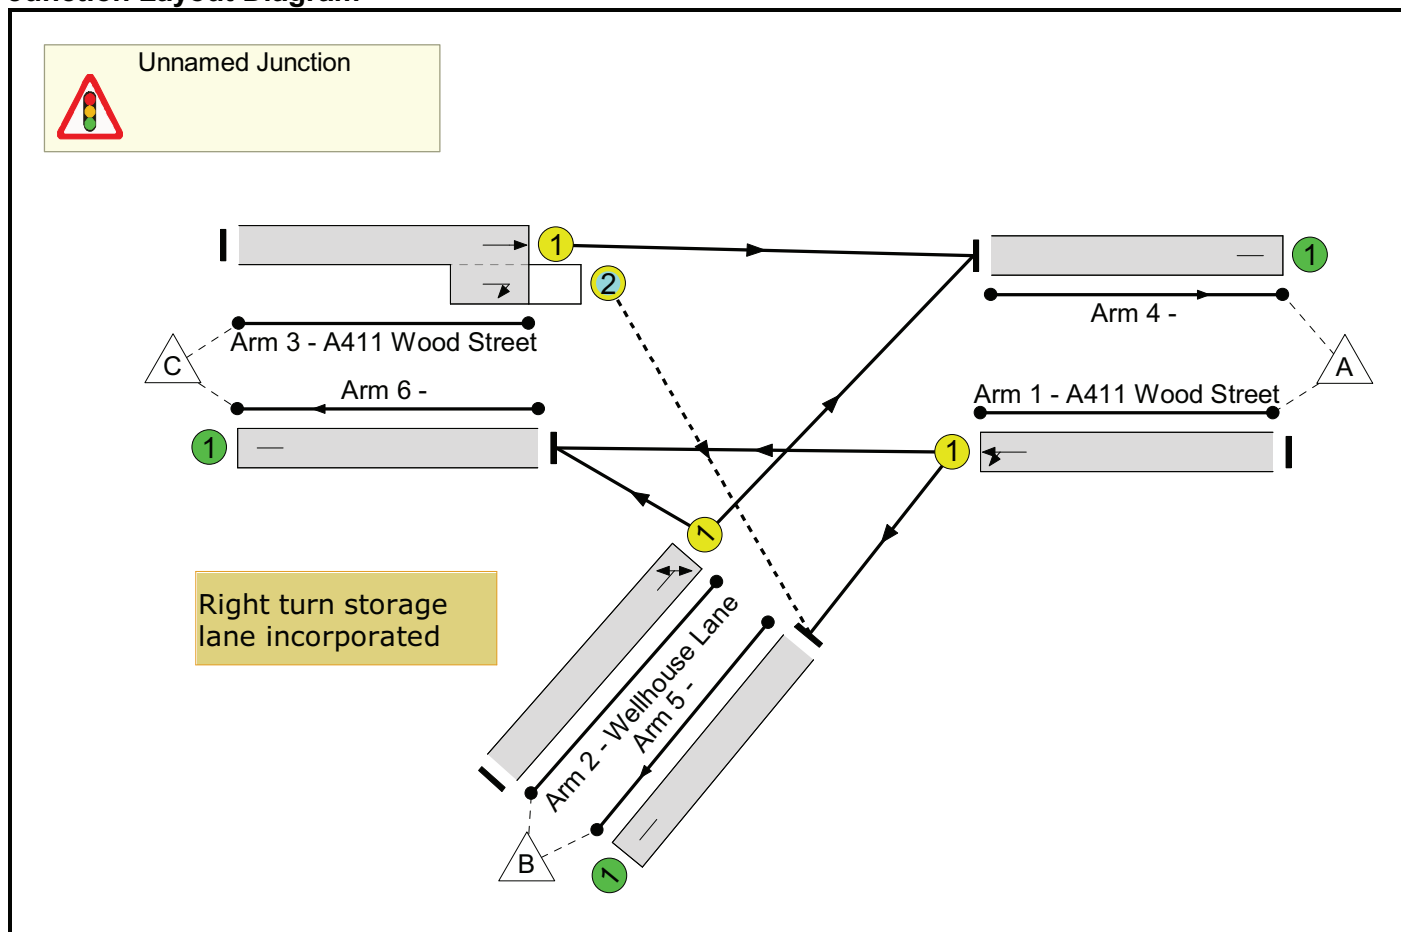
Junction Layout Diagram

Project:	Barnet Local Improvement Plan 2013-14
Title:	LinSig Analysis Option 3
Location:	A411/Wellhouse Lane
Company:	Capita
Address:

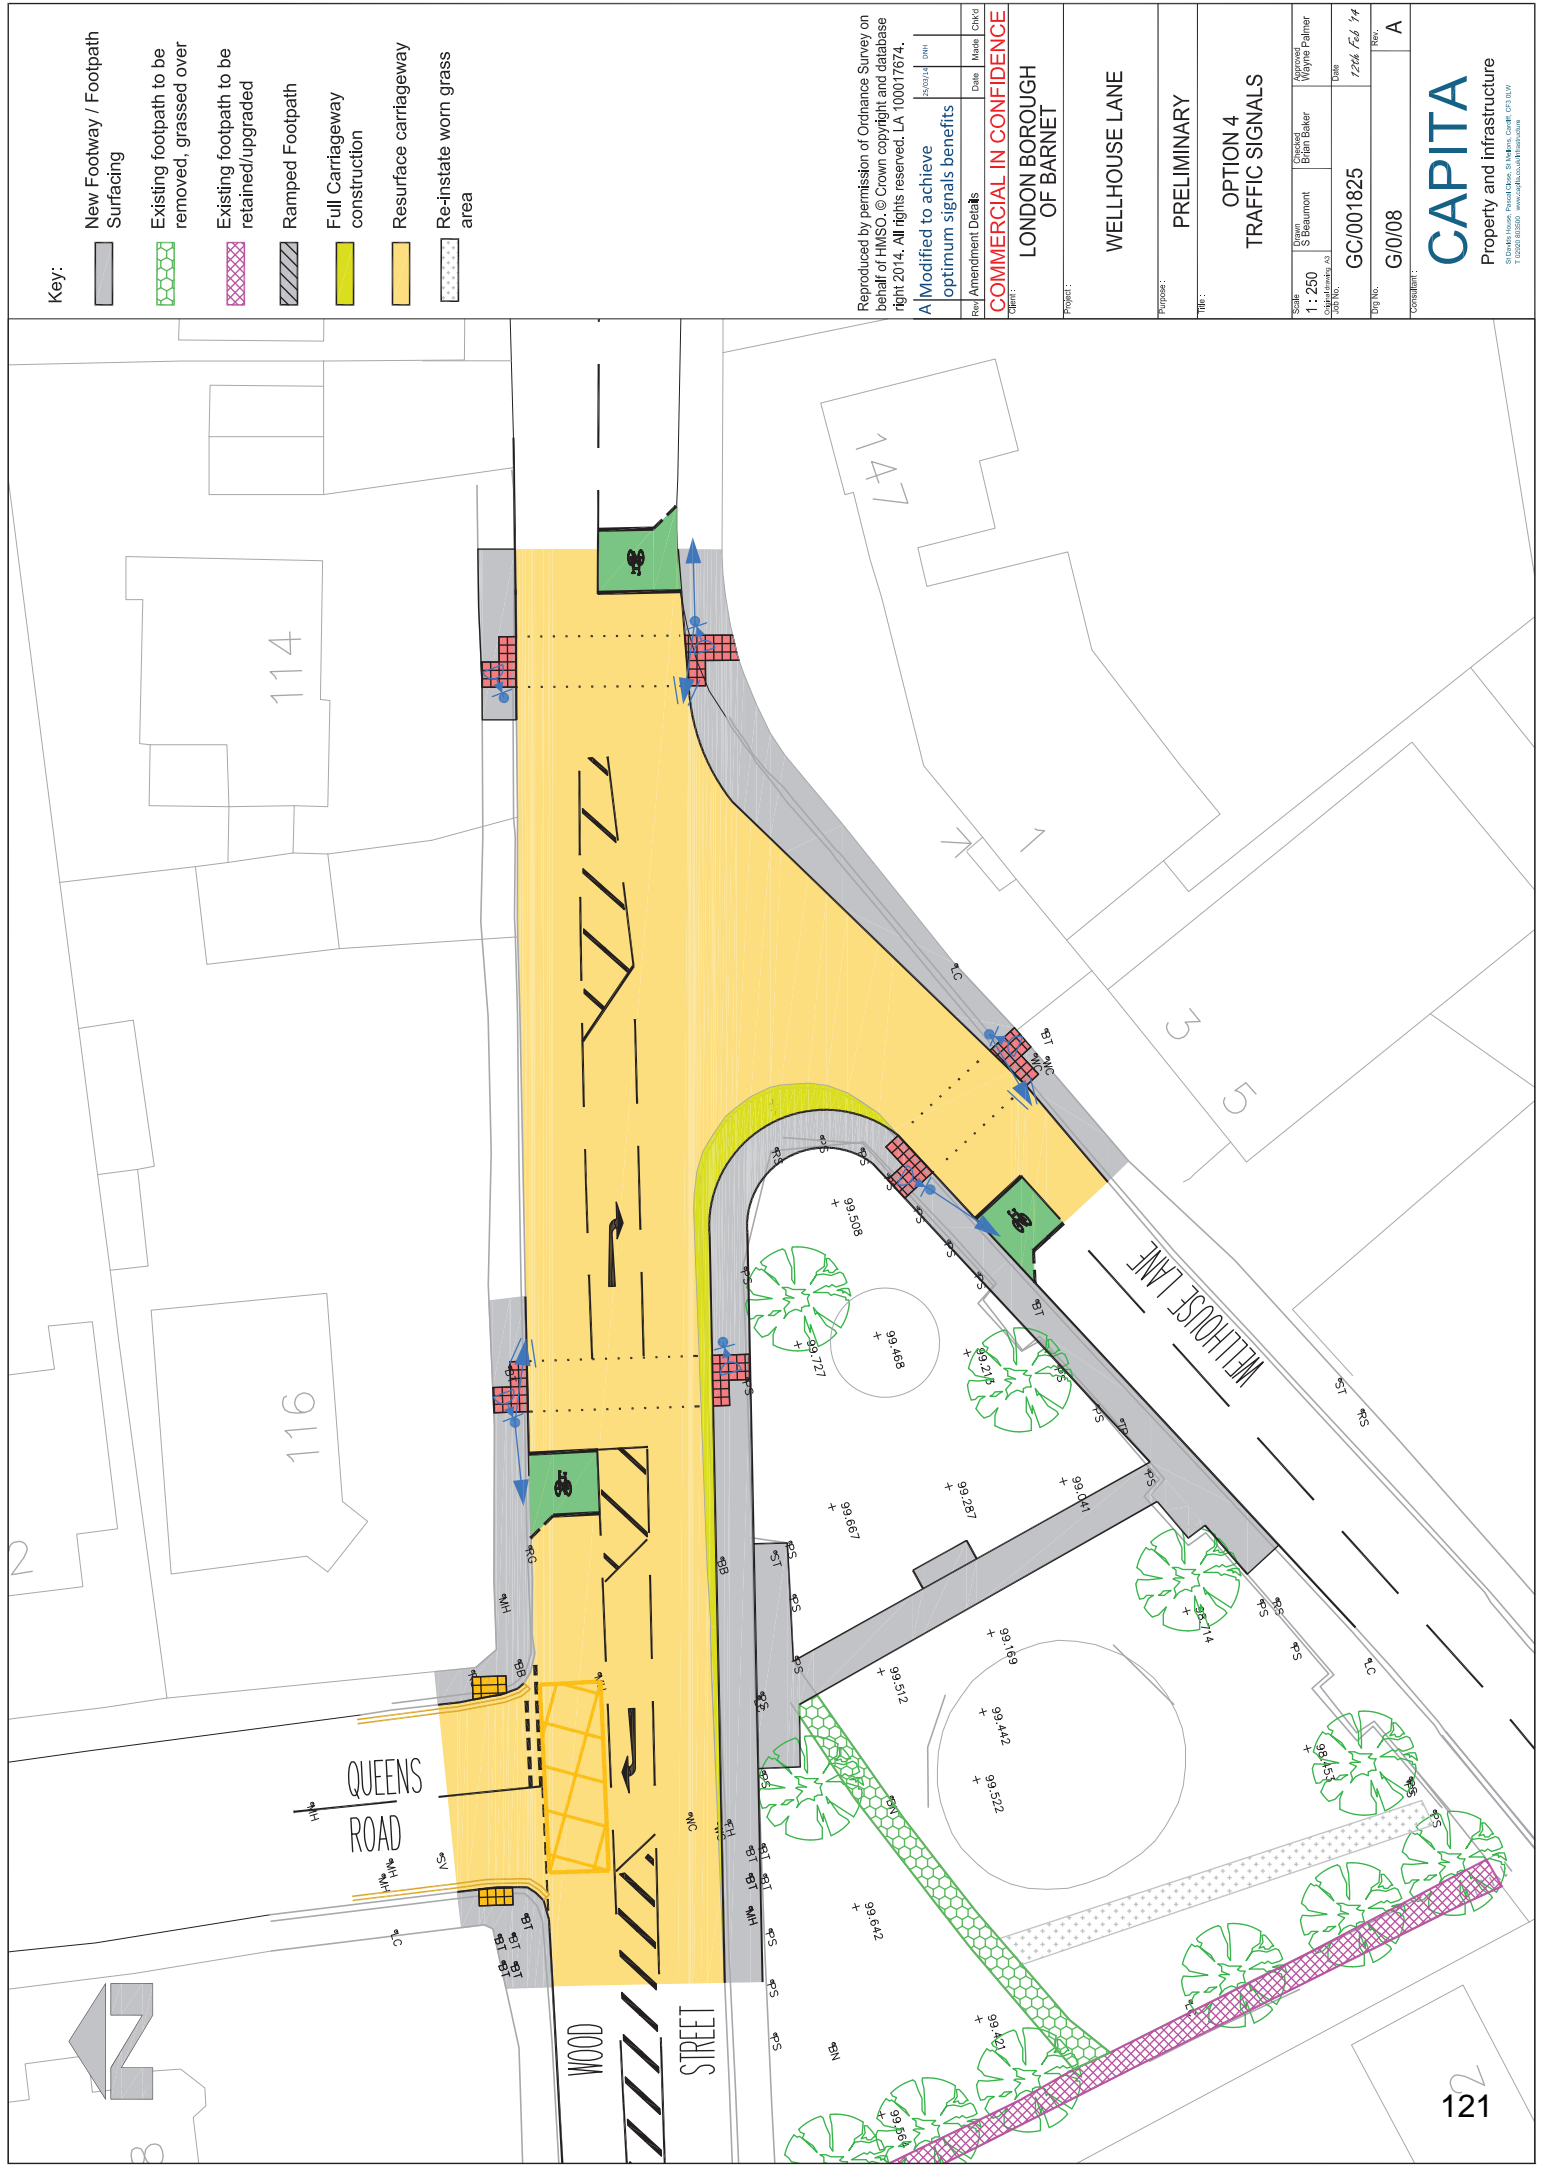
Scale: 1:250
 Date: 12th Feb 14
 Project No: GC/001825
 Contract: G/0/14

- New Footway / Footpath Surfacing
- Existing footpath to be removed, grassed over
- Existing footpath to be retained/upgraded
- Ramped Footpath
- Full Carriageway construction
- Resurface carriageway
- Re-instate worn grass area

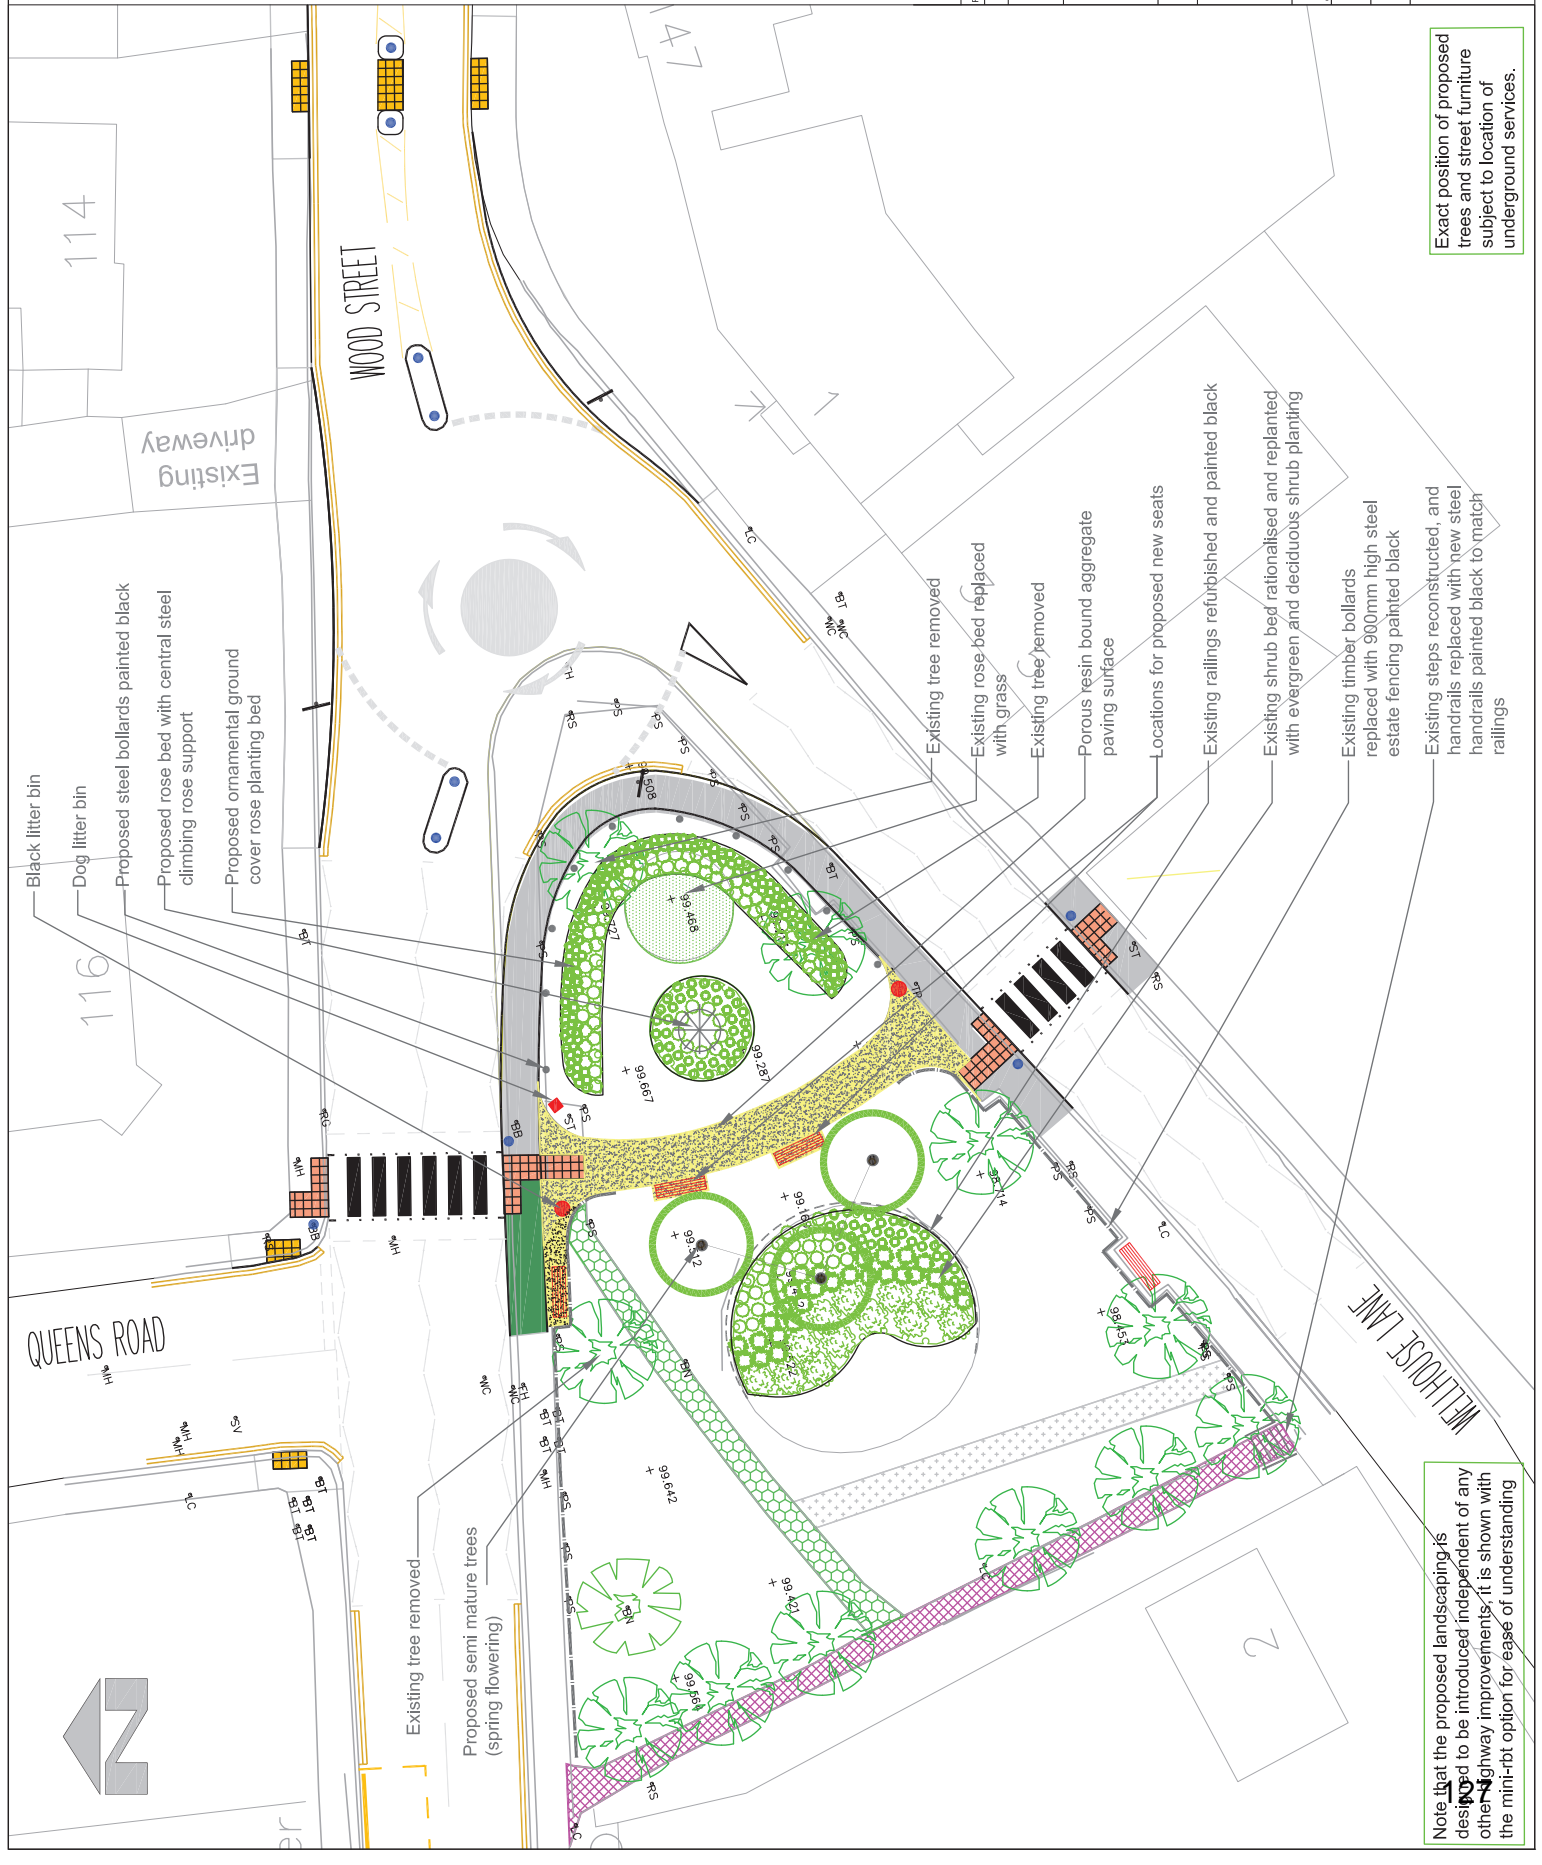
Exact position of proposed trees and street furniture subject to location of underground services.

Note that the proposed landscaping is designed to be introduced independent of any other highway improvements; it is shown with the mini-bt option for ease of understanding

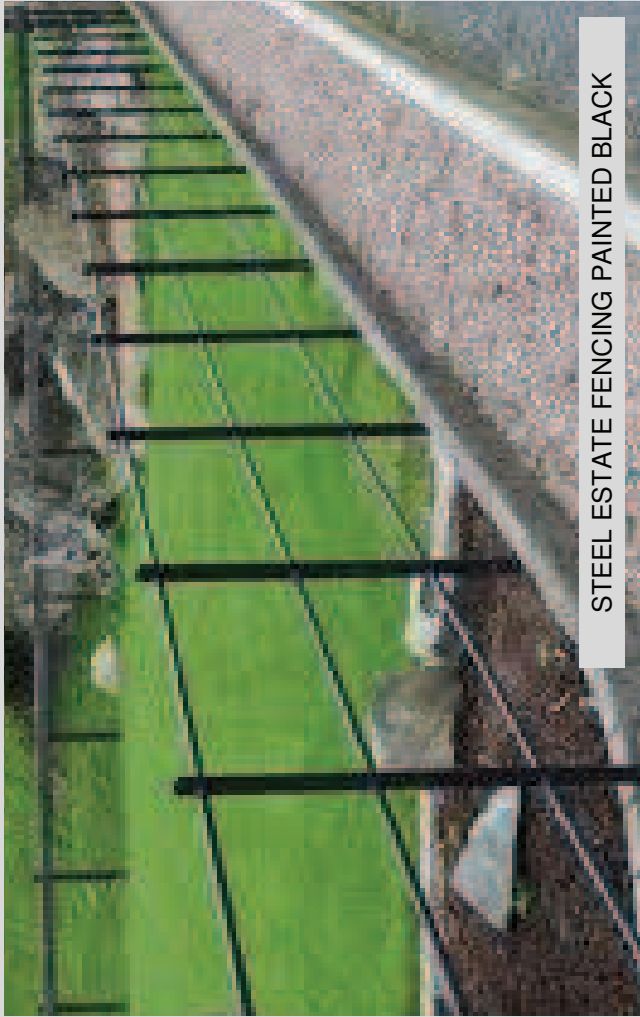
STEEL ESTATE FENCING PAINTED BLACK

- 11.6 The existing timber posts surrounding the green area are in a relatively poor condition, they are being replaced with new low maintenance steel bollards to the east of the path and by 900mm high black painted steel estate fencing. This fencing is intended to discourage errant walking across the grassed area.
