MEETING**CHIPPING BARNET AREA COMMITTEE****DATE AND TIME****WEDNESDAY 22ND OCTOBER, 2014****AT 7.00 PM****VENUE****1255 HIGH ROAD, WHETSTONE, N20 0EJ**

Title	Wellhouse Lane Pedestrian & Safety Improvements
Report of	Declan Hoare – Lead Commissioner for Housing and Environment
Wards	High Barnet
Status	Public
Enclosures	Appendix A: <i>Wellhouse Lane – Barnet Highway and Pedestrian Assessment Report of 31 March 2014.</i> Appendix B: <i>Drawing Nos. G/0/14-15, 17 & 18</i>
Officer Contact Details	Themba.Nleya, Senior Engineer – Traffic & Development, Themba.Nleya@Barnet.gov.uk , Telephone 0208 359 4198 Lisa Wright, Traffic & Development Manager Lisa.Wright@Barnet.gov.uk , Telephone 0208 359 3049

Wellhouse Lane - Barnet Highway and Pedestrian Assessment

31st March 2014

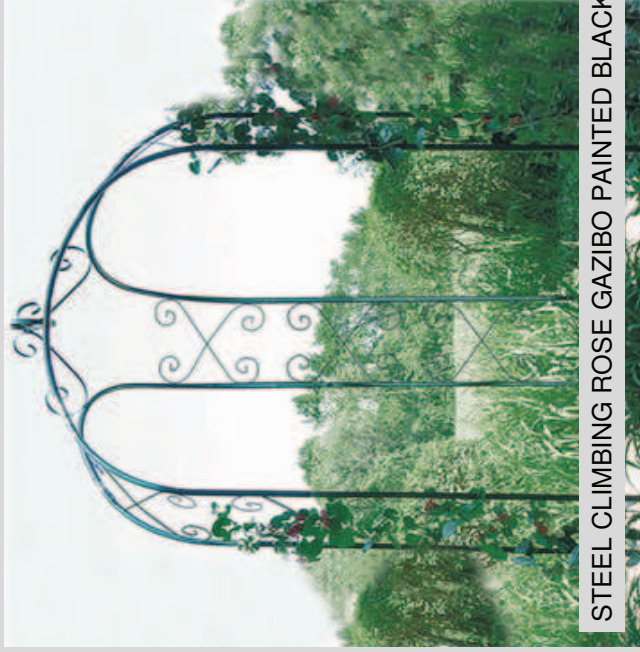
STEEL CLIMBING ROSE GAZIBO PAINTED BLACK

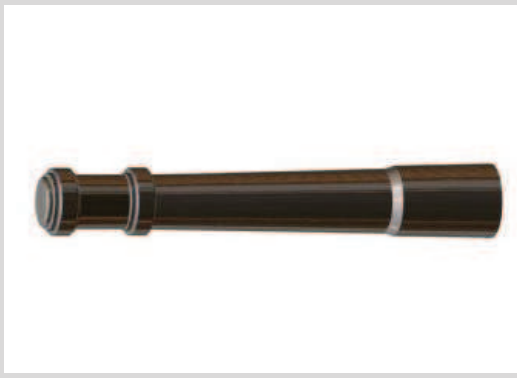
LOW SUNDERLAND BOLLARD BLACK

- 11.6 The existing timber posts surrounding the green area are in a relatively poor condition, they are being replaced with new low maintenance steel bollards to the east of the path and by 900mm high black painted steel estate fencing. This fencing is intended to discourage errant walking across the grassed area.

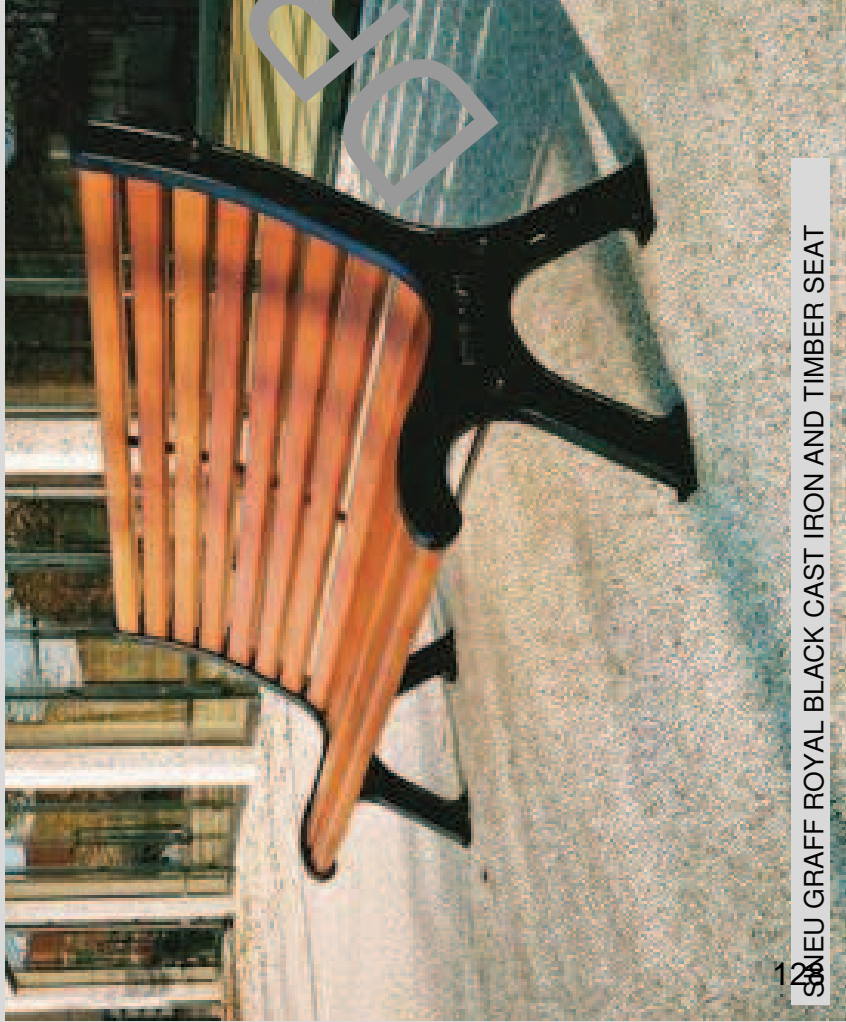
BENUE GRAFF ROYAL BLACK CAST IRON AND TIMBER SEAT

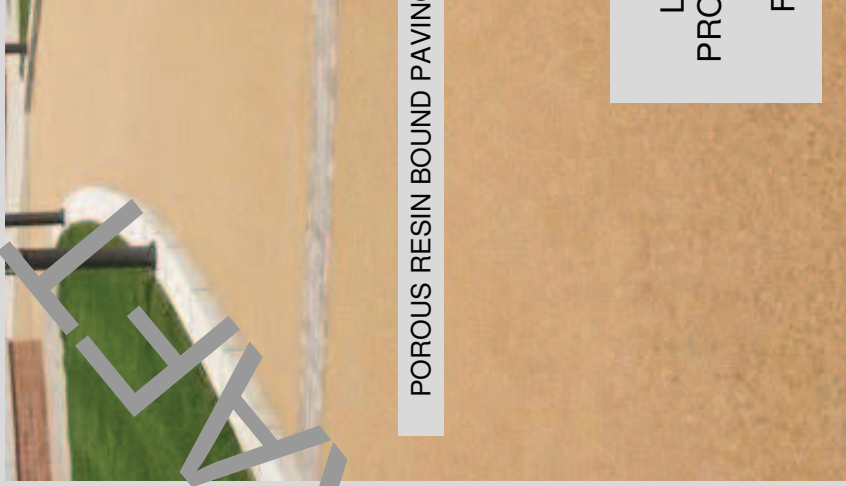
POROUS RESIN BOUND PAVING WITH STEEL EDGE TO ACHIEVE CURVES

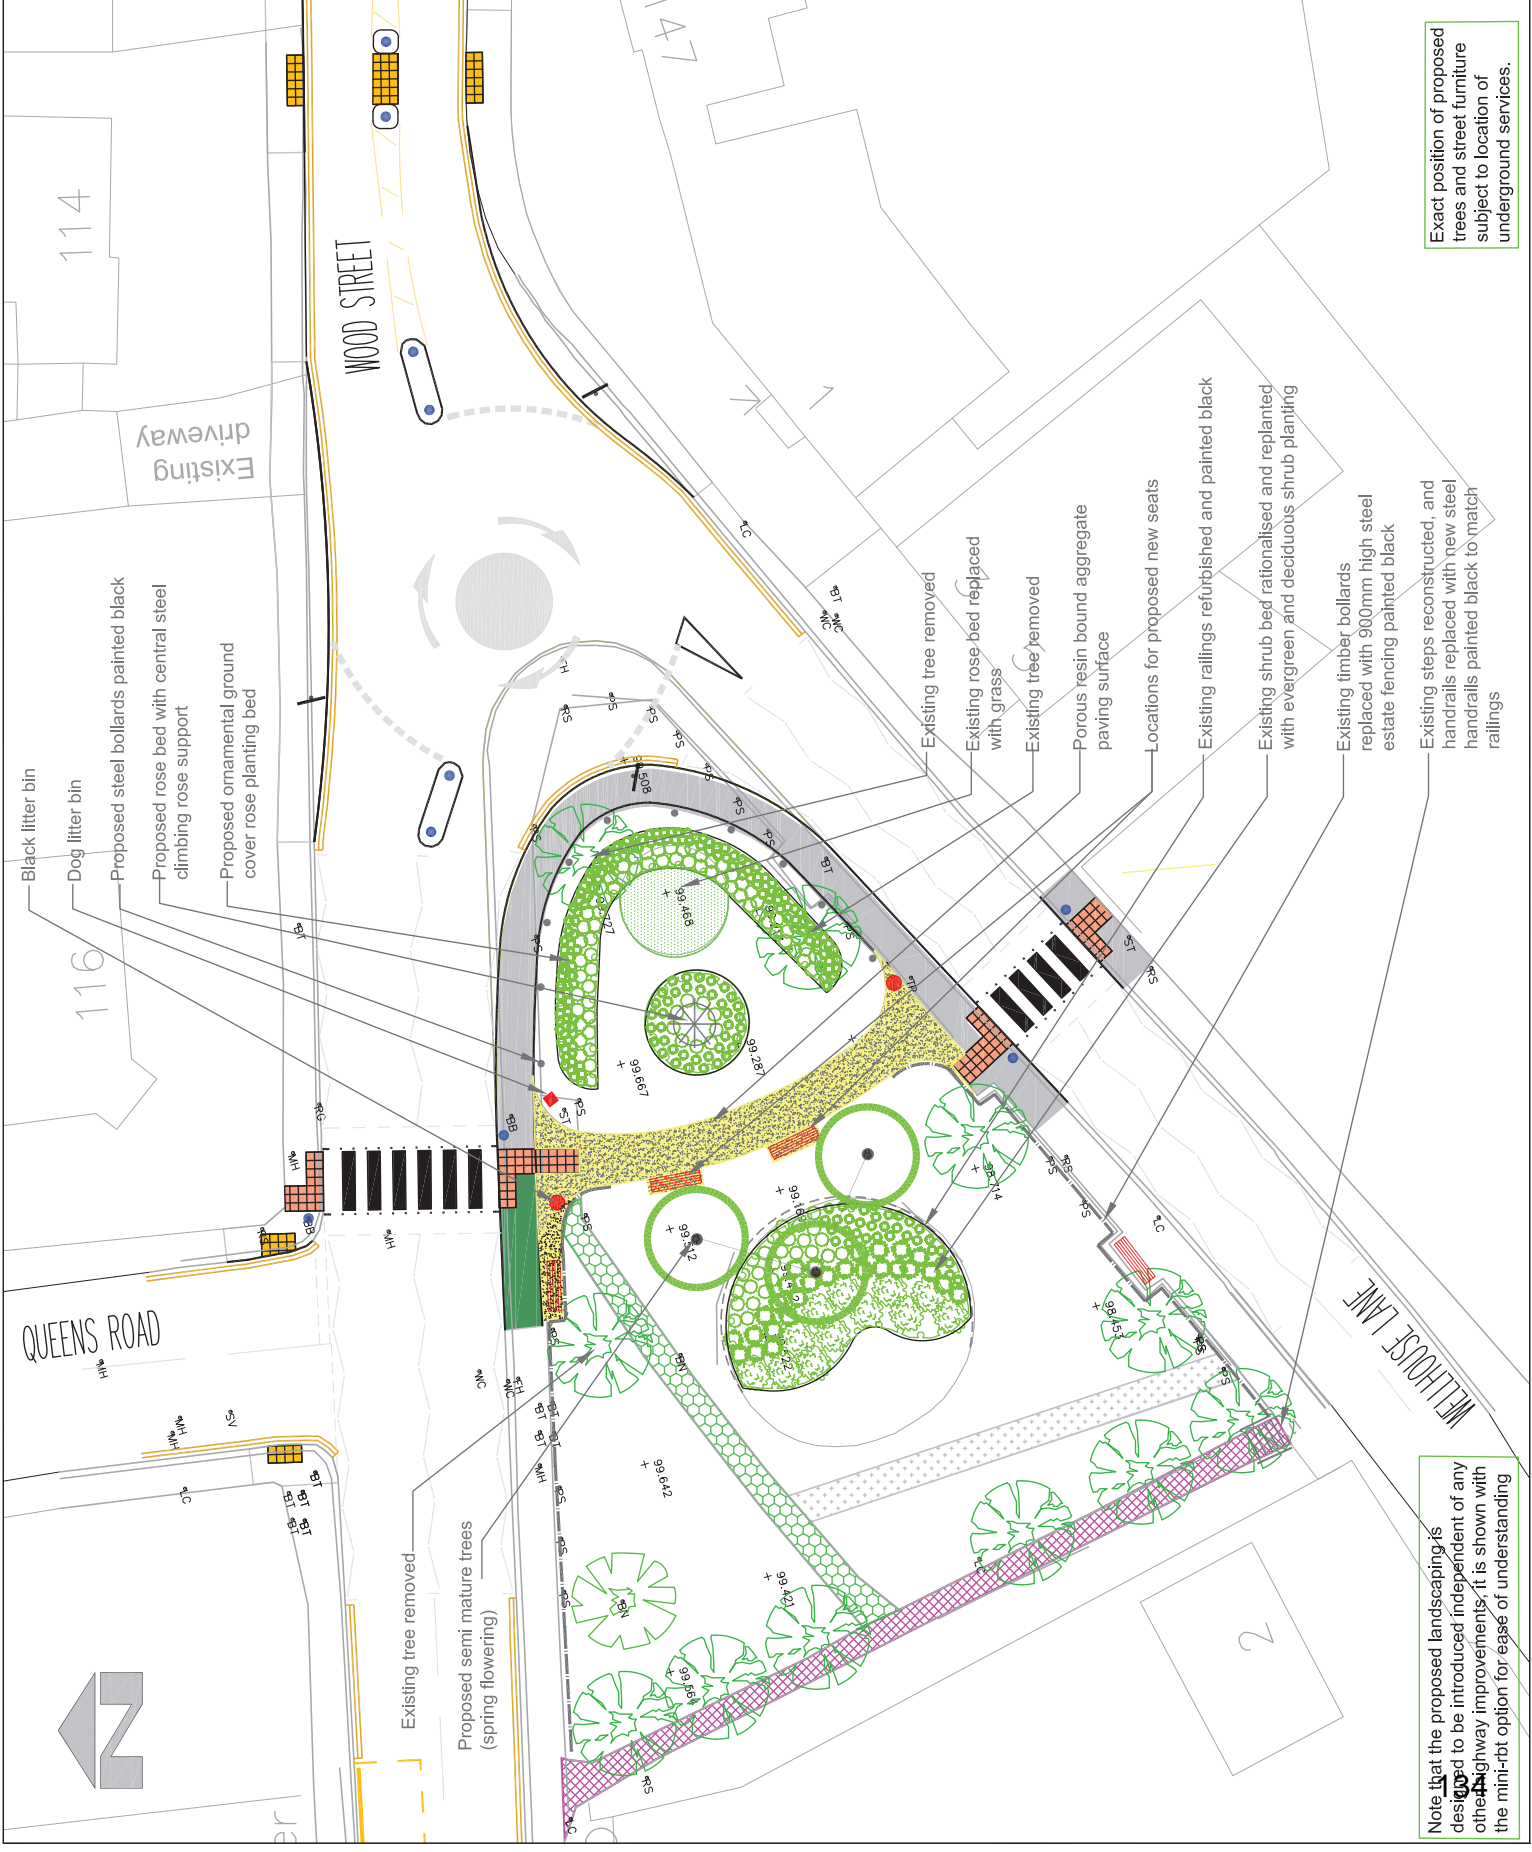
COMMERCIAL IN CONFIDENCE
 CLIENT: LONDON BOROUGH OF BARNET
 PROJECT: WELLHOUSE LANE
 PROPOSED: PRELIMINARY
 TITLE: Landscape Proposal

Exact position of proposed trees and street furniture subject to location of underground services.

Note that the proposed landscaping is designed to be introduced independent of any other highway improvements; it is shown with the mini-bt option for ease of understanding
