Appendix 1:

A. Types of defects meeting the intervention levels (Extract from HISIM).

B. Network Examples for Intervention and Non Intervention Situations
Footway (Pavement)

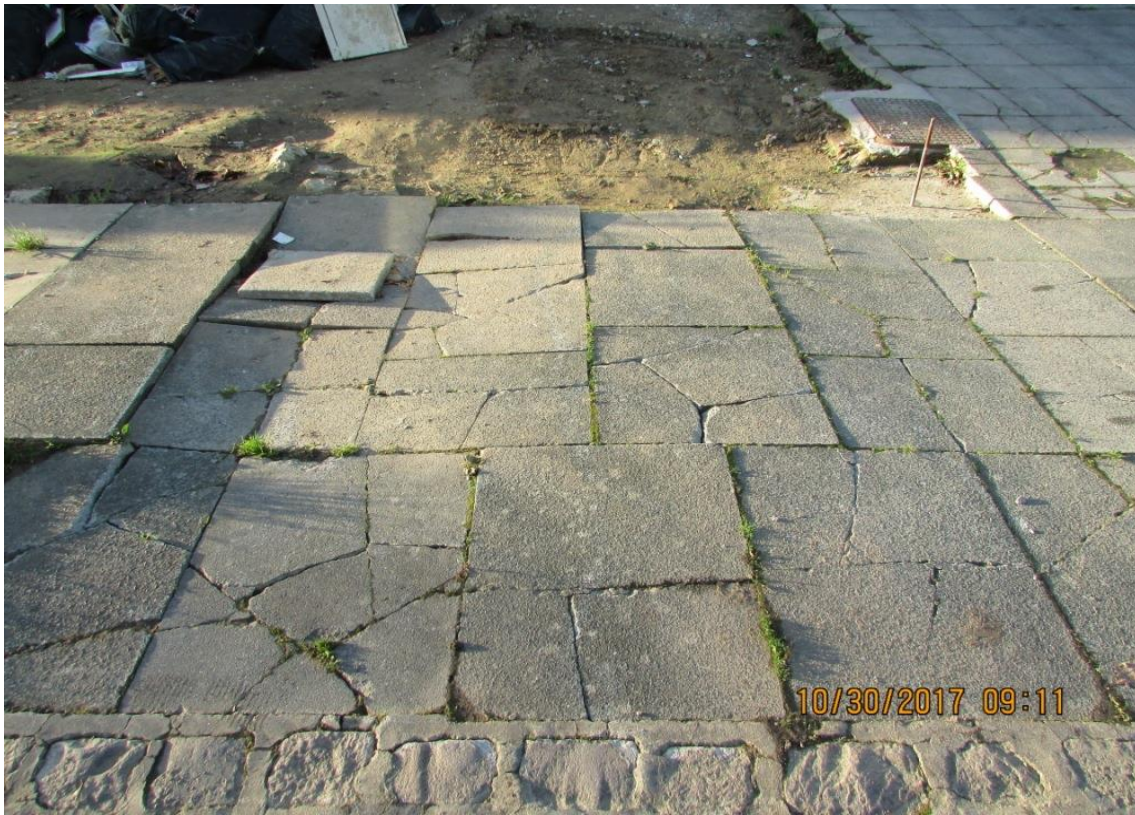
Intervention level

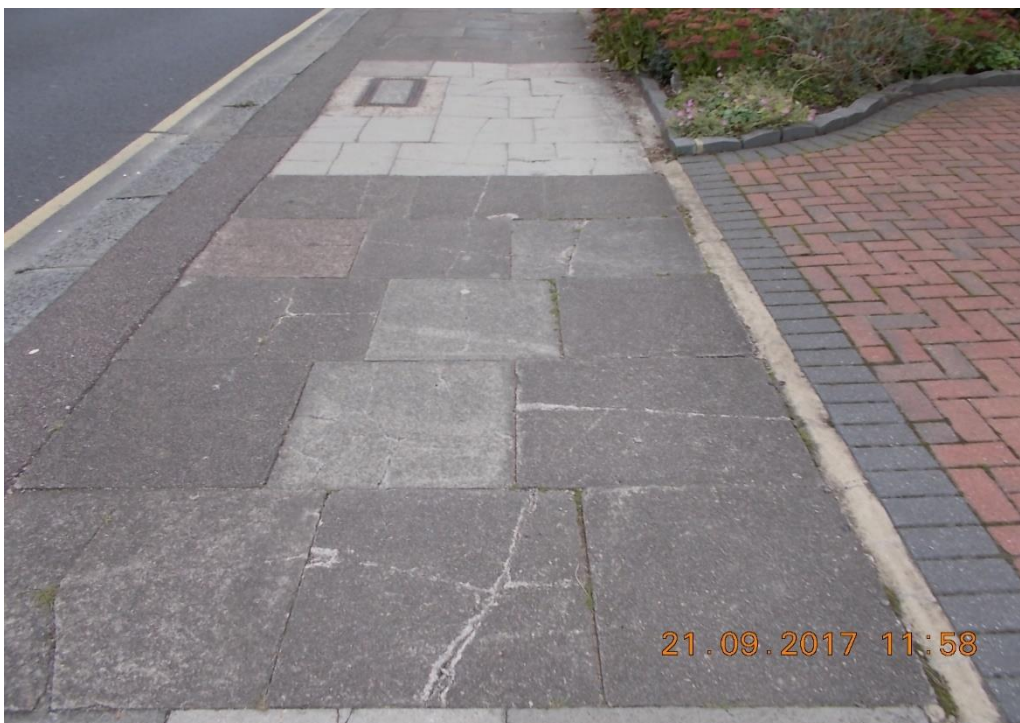
Not at intervention level

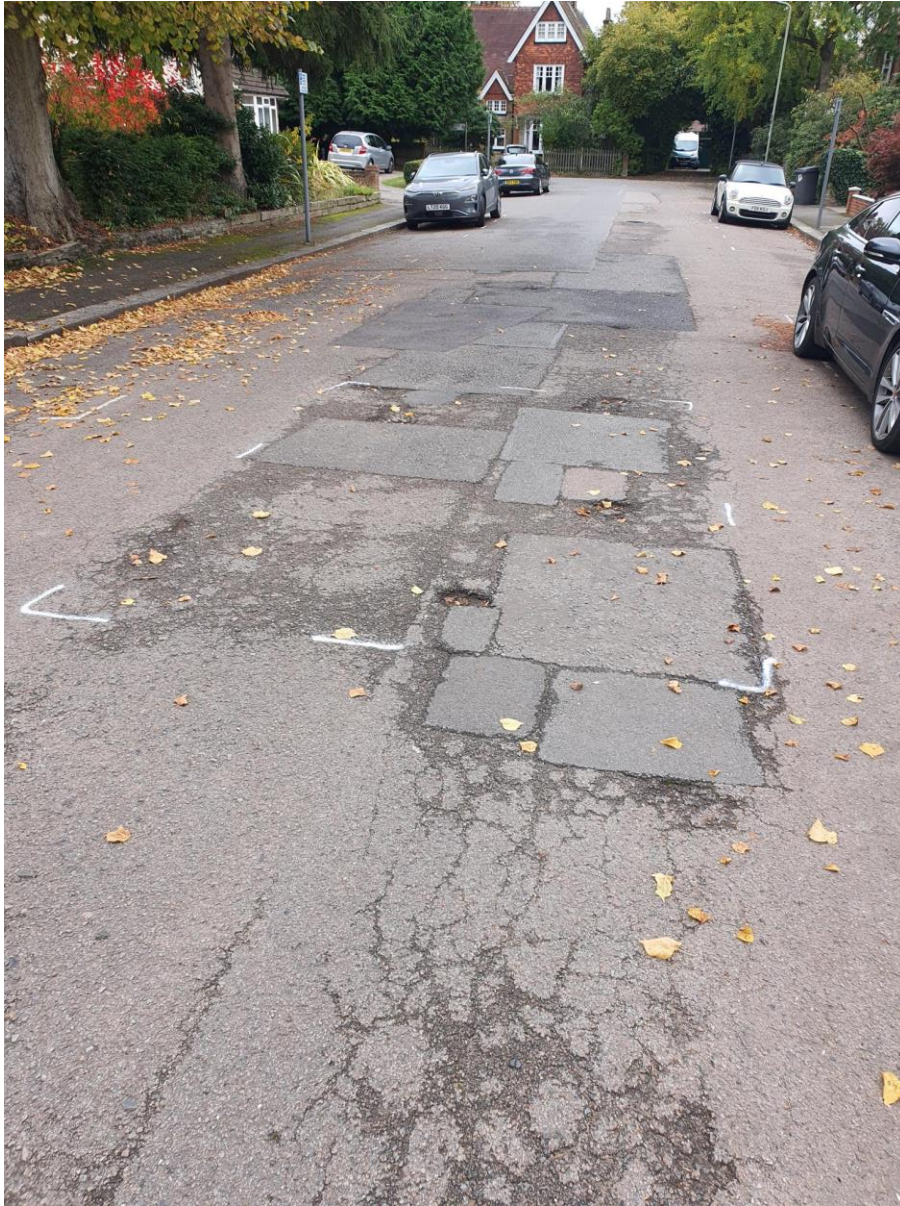
Carriageway (Road)

Intervention level

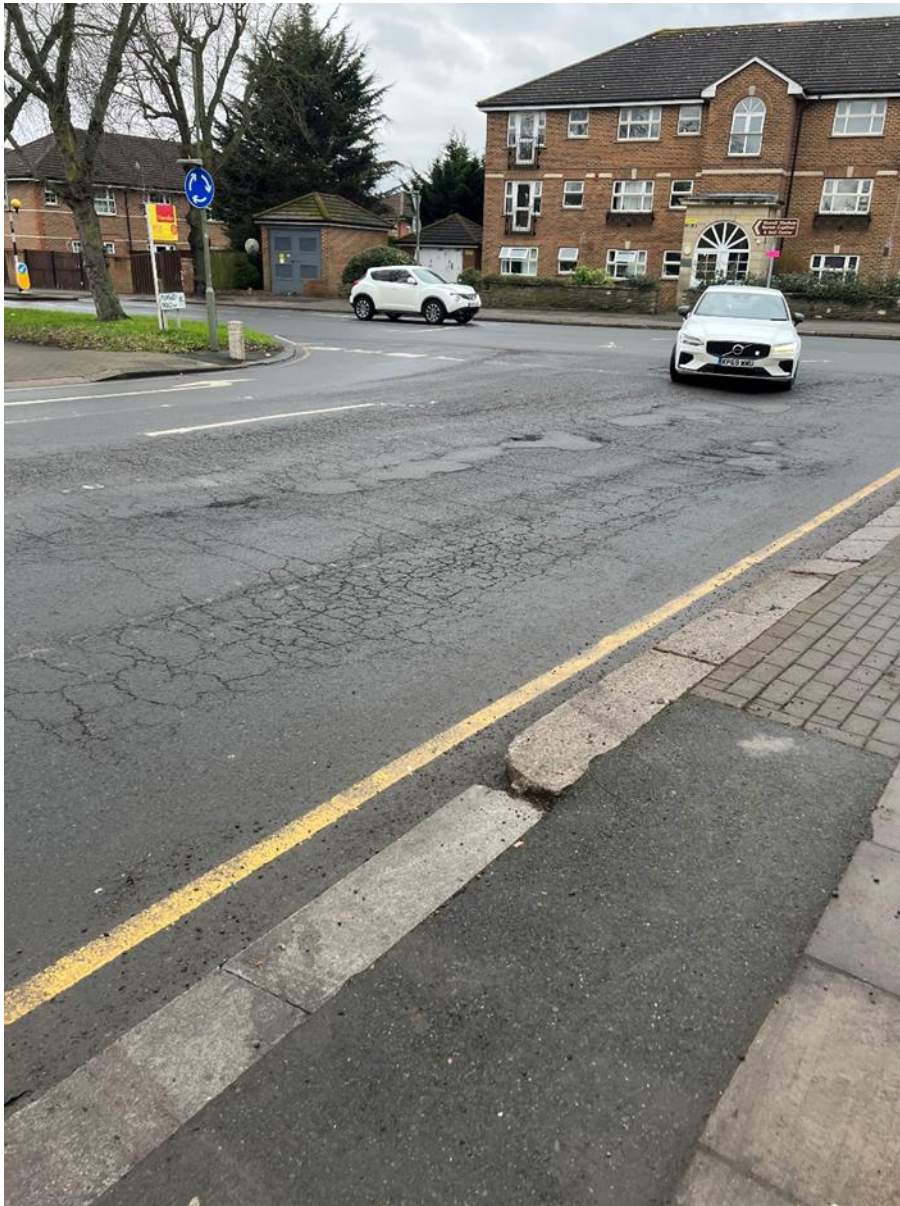
Carriageway (Road)

Not at intervention level
